# Inspection Report

**MDE-RVI: Machine Diagnostic Engineering - Remote Visual Inspections**

This inspection was performed following the air gap inspection of wind turbine. The remaining time was used to perform a partly inspection after a blown out of the coil 23. Due to limited time, it was decided to inspect only the damaged area of the turbine from coil 22 until coil 50.

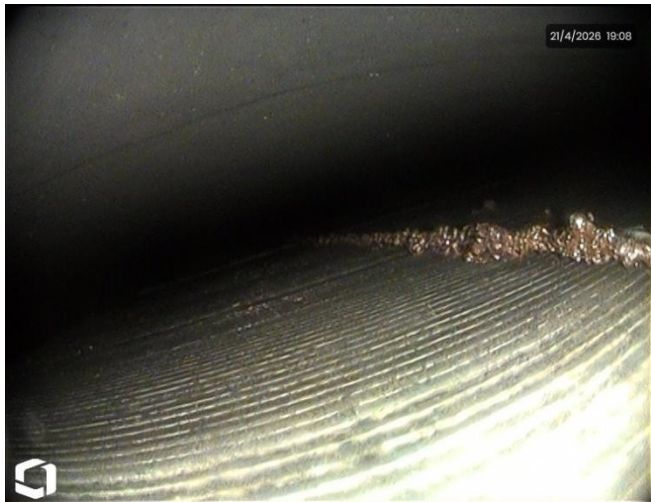
| Findings | Photo number |
|---|---|
| Debris, paint damage. | 1 |

**Photo 1: Coil 22. Debris and paint damage.**

- Replace magnets 63-70 and coils 22-30.
- Items 31 through 50 require reassessment for replacement because of blackened, heat-damaged insulation.
- Because the inspection was only partial, it is recommended to perform a full 360° inspection.
- It is recommended to clean and inspect due to the presence of debris inside the air gap.
- Conduct an annual inspection of the coils and magnets to detect any pollution or damage at an early stage.

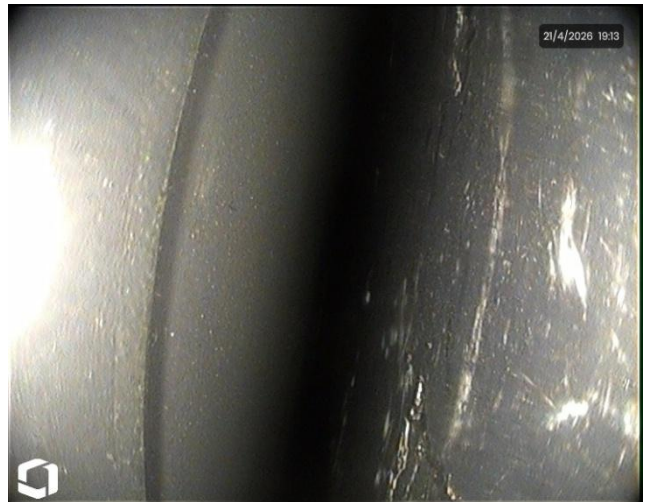
| Findings | Photo number |
|---|---|
| Burnt coil. | 2 |

**Photo 2: Coil 23. Debris and burn surface.**

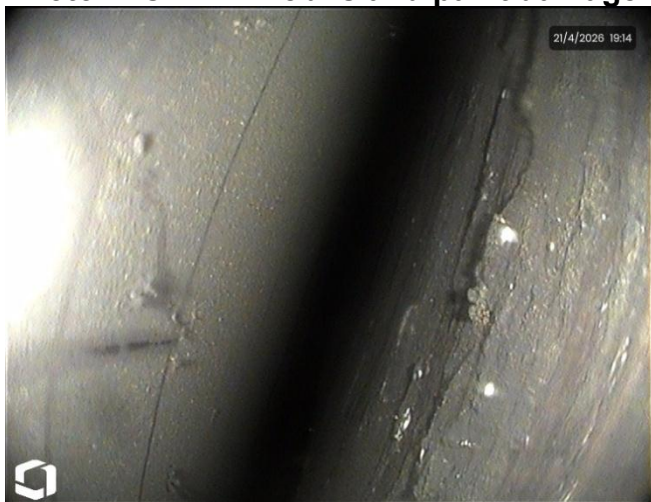
| Findings | Photo number |
|---|---|
| Burnt coil. | 3 |

**Photo 3: Coil 24 Debris and burn surface.**

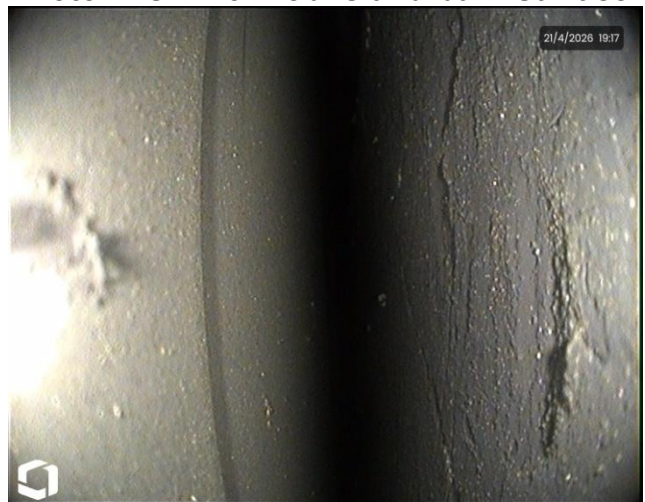
| Findings | Photo number |
|---|---|
| Burnt coil. | 4 |

**Photo 4: Coil 25. Debris and burn surface.**

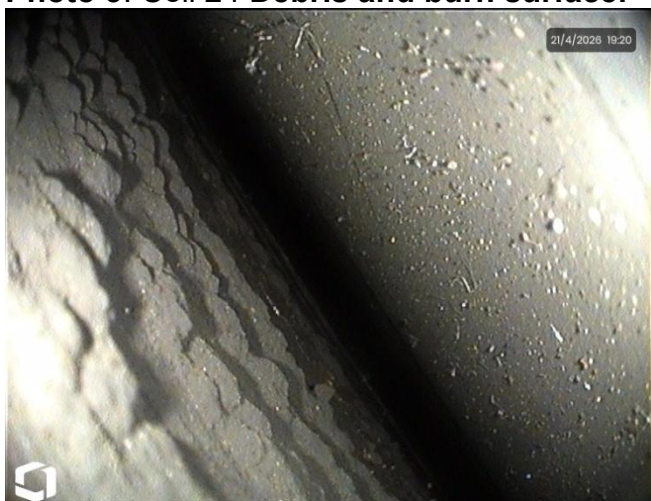
| Findings | Photo number |
|---|---|
| Burnt coil. | 5 |

**Photo 5: Coil 26. Debris and burn surface.**

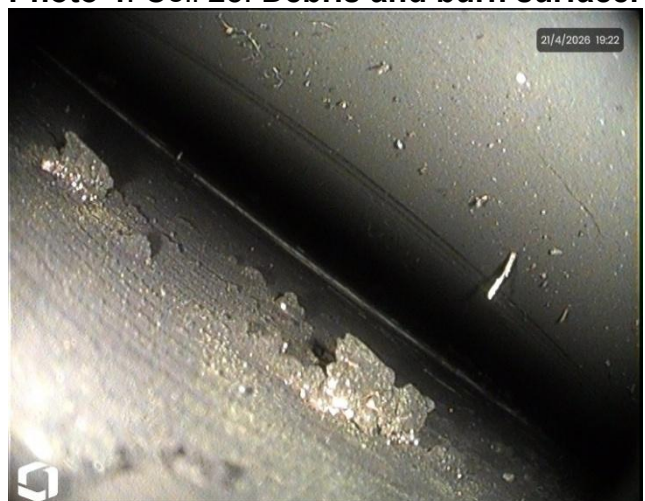
| Findings | Photo number |
|---|---|
| Burnt coil. | 6 |

**Photo 6: Coil 27. Debris and burn surface.**

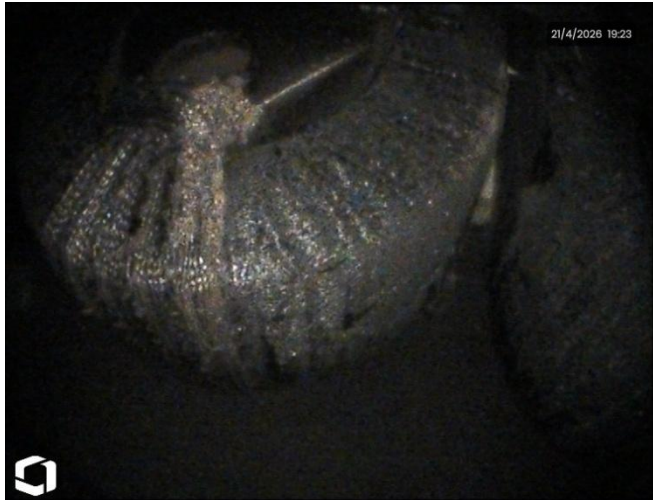
| Findings | Photo number |
|---|---|
| Burnt coil. | 7 |

**Photo 7: Coil 28. Debris and paint damage.**

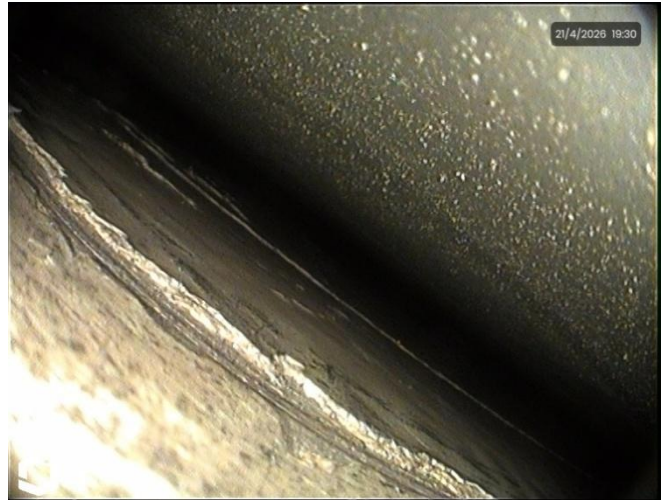
| Findings | Photo number |
|---|---|
| Burnt coil. | 8 |

**Photo 8: Coil 29. Debris and burn surface.**

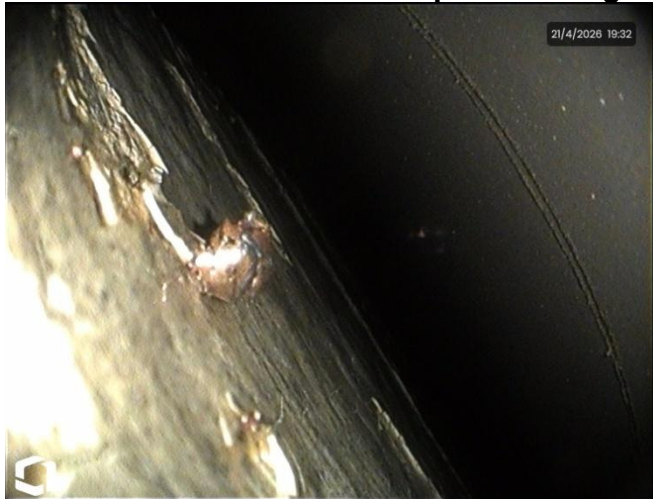
| Findings | Photo number |
|---|---|
| Burnt coil. | 9 |

**Photo 9: Coil 30. Debris and paint damage.**

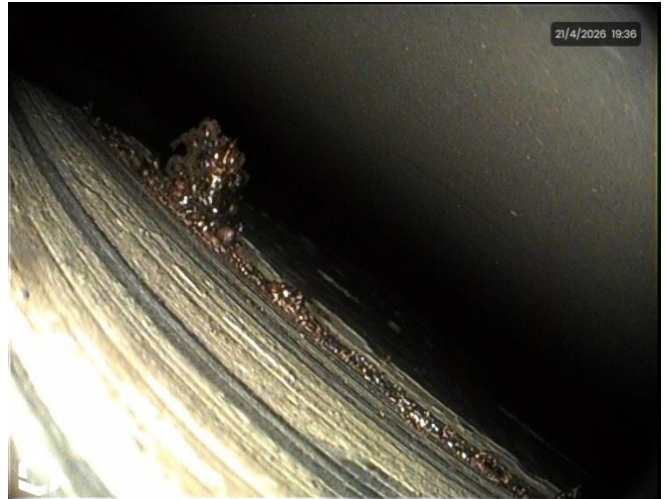
| Findings | Photo number |
|---|---|
| Debris, paint damage. | 10 |

**Photo 10: Coil 31. Debris and paint damage.**

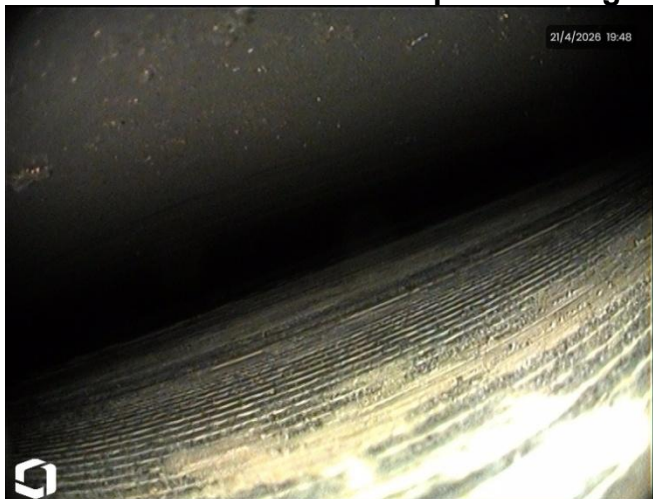
| Findings | Photo number |
|---|---|
| Debris, paint damage. | 11 |

**Photo 11: Coil 32. Debris and paint damage.**

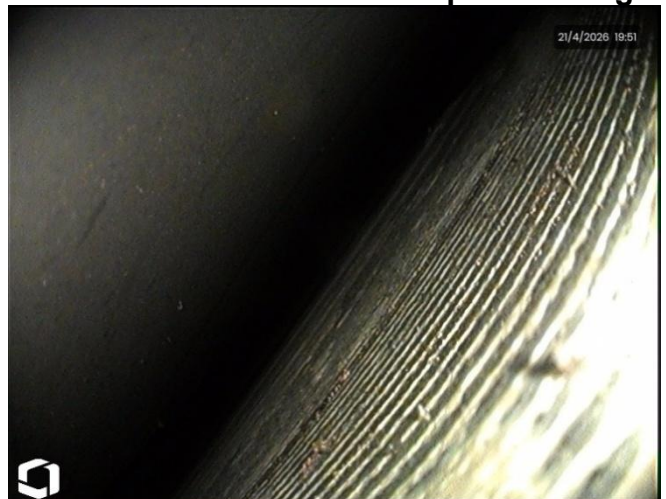
| Findings | Photo number |
|---|---|
| Debris, paint damage. | 12 |

**Photo 12: Coil 33. Debris and paint damage.**

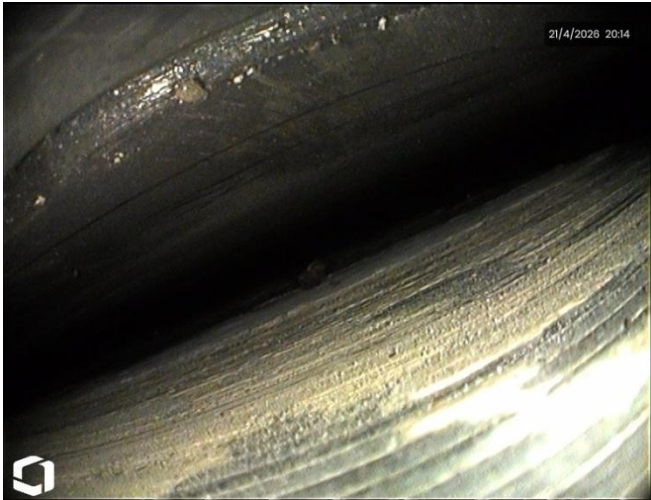
| Findings | Photo number |
|---|---|
| Debris, paint damage. | 13 |

**Photo 13: Coil 34. Debris and delamination.**

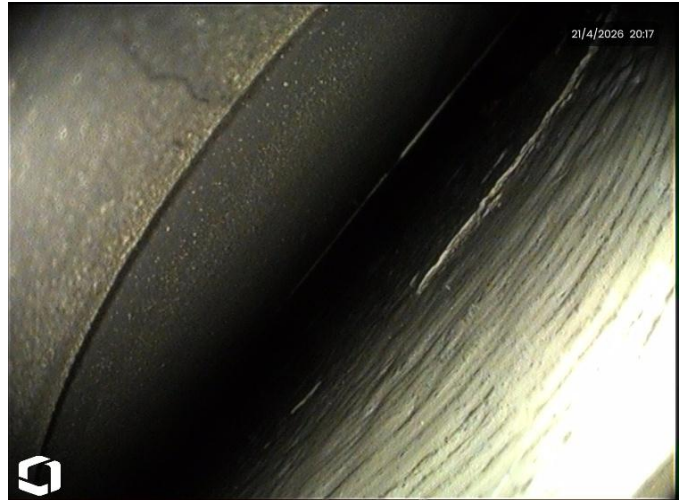
| Findings | Photo number |
|---|---|
| Debris, paint damage. | 14 |

**Photo 14: Coil 35. Debris and delamination.**

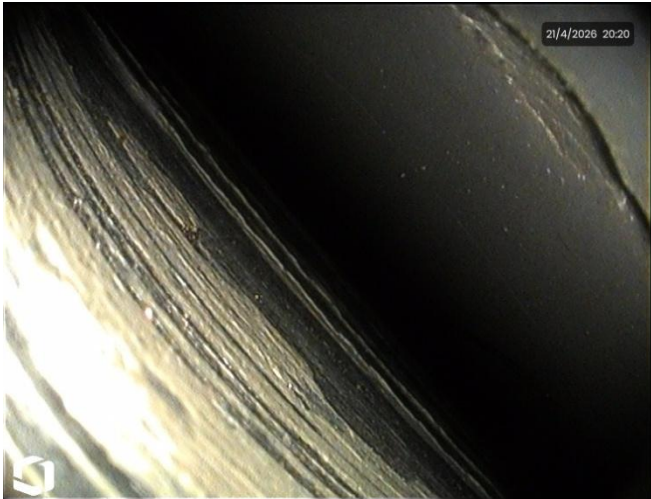
| Findings | Photo number |
|---|---|
| Debris, paint damage. | 15 |

**Photo 15: Coil 36. Debris and delamination.**

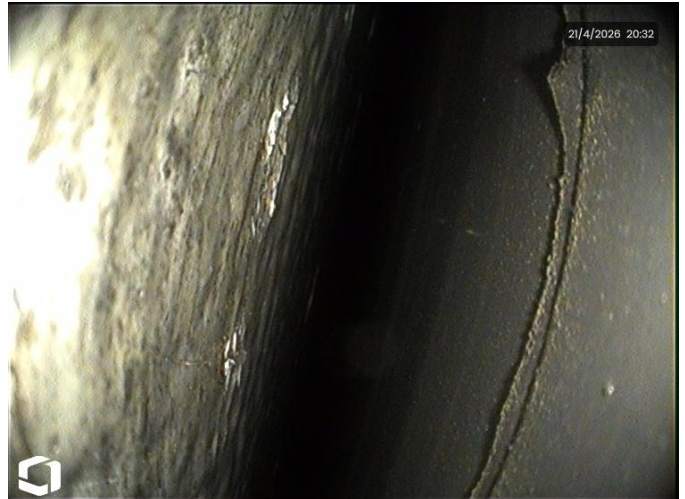
| Findings | Photo number |
|---|---|
| Debris, paint damage. | 16 |

**Photo 16: Coil 37. Debris and paint damage.**

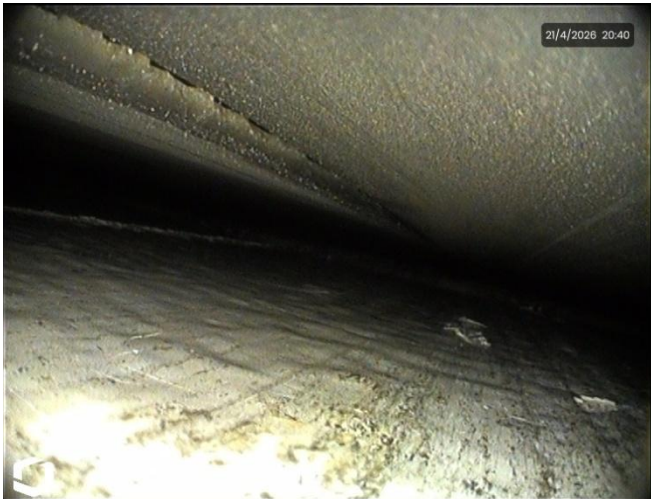
| Findings | Photo number |
|---|---|
| Debris, paint damage. | 17 |

**Photo 17: Coil 38. Debris and delamination.**

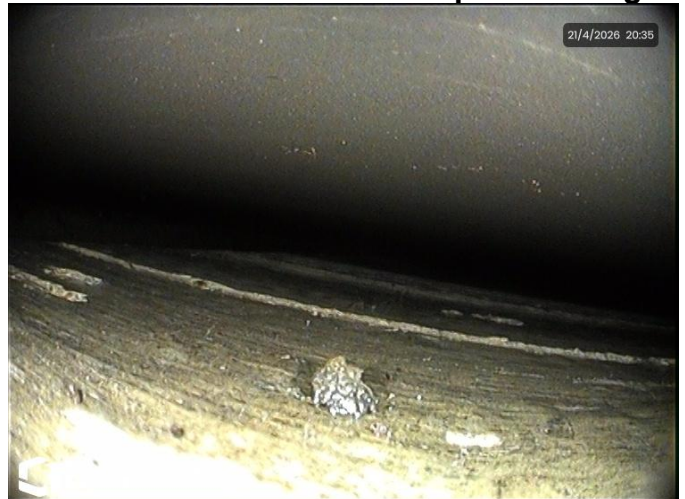
| Findings | Photo number |
|---|---|
| Debris, paint damage. | 18 |

**Photo 18: Coil 39. Debris and paint damage**

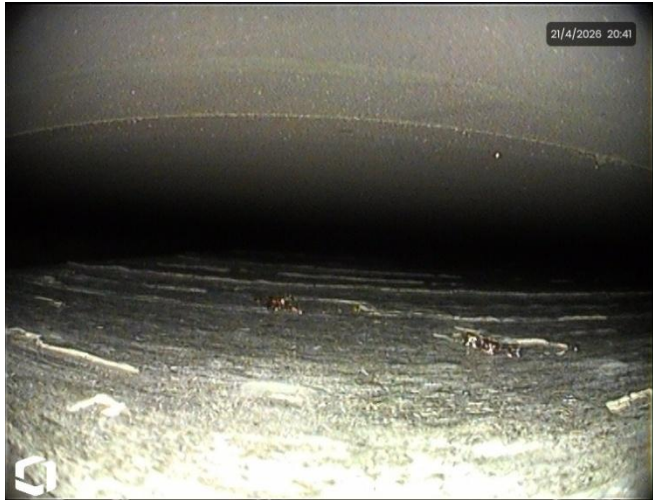
| Findings | Photo number |
|---|---|
| Debris, paint damage. | 19 |

**Photo 19: Coil 40. Debris and paint damage.**

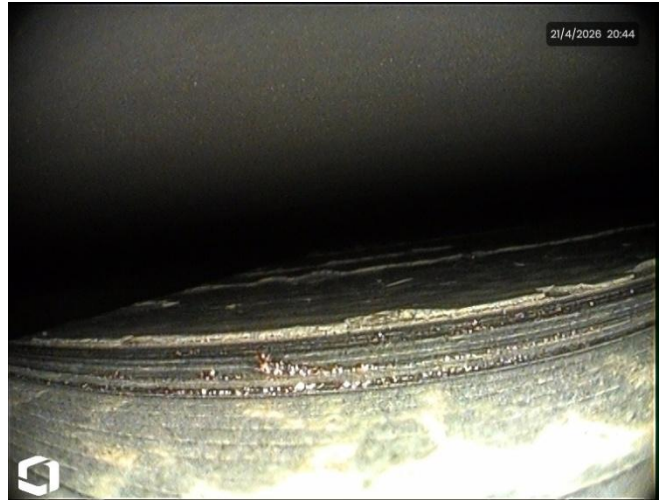
| Findings | Photo number |
|---|---|
| Debris, paint damage. | 20 |

**Photo 20: Coil 41. Debris and paint damage.**

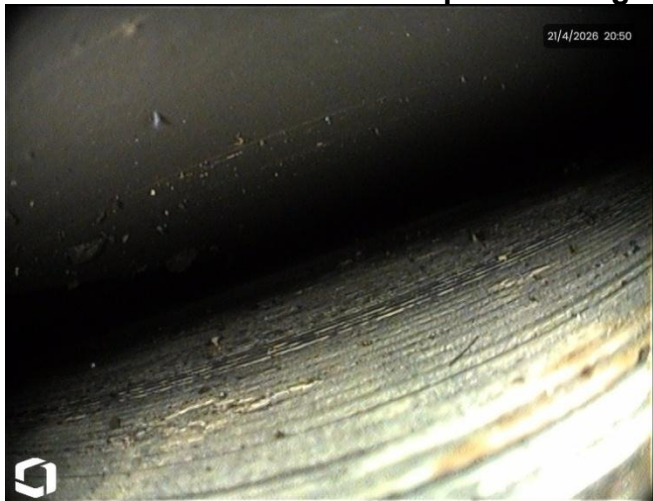
| Findings | Photo number |
|---|---|
| Debris, paint damage. | 21 |

**Photo 21: Coil 42. Debris and paint damage.**

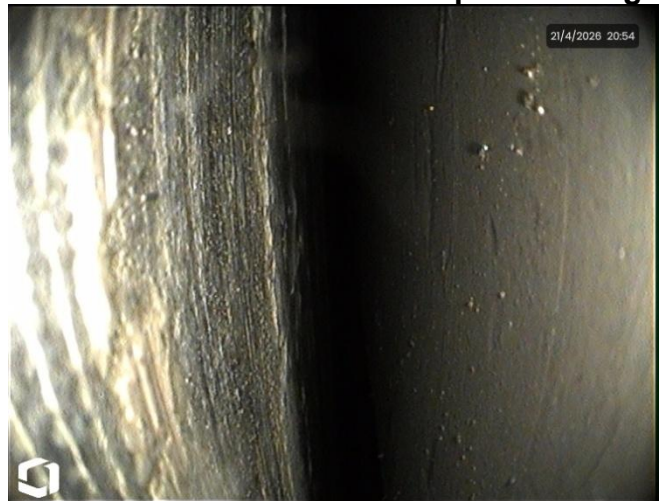
| Findings | Photo number |
|---|---|
| Debris, paint damage. | 22 |

**Photo 22: Coil 43. Debris and paint damage.**

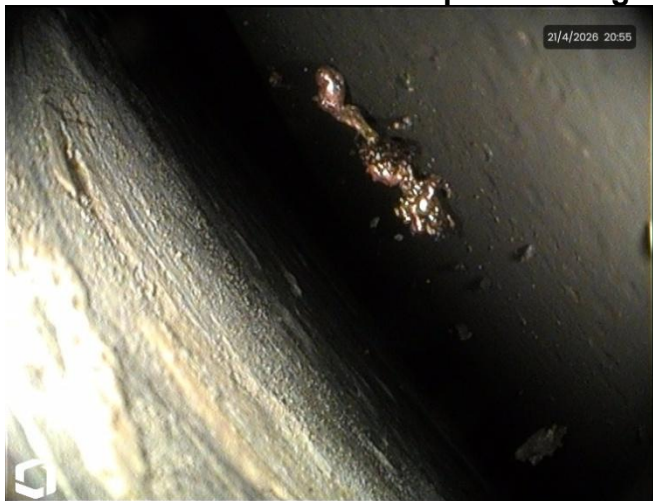
| Findings | Photo number |
|---|---|
| Debris, paint damage. | 23 |

**Photo 23: Coil 44. Debris and paint damage.**

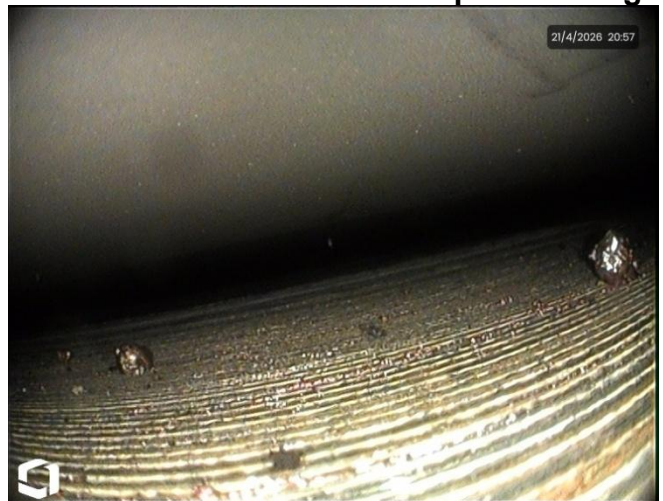
| Findings | Photo number |
|---|---|
| Debris, paint damage. | 24 |

**Photo 24: Coil 45. Debris and paint damage.**

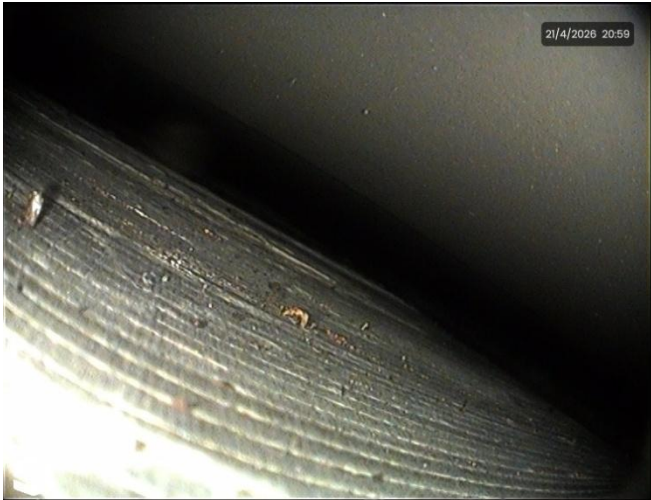
| Findings | Photo number |
|---|---|
| Debris, paint damage. | 25 |

**Photo 25: Coil 46. Debris and paint damage**

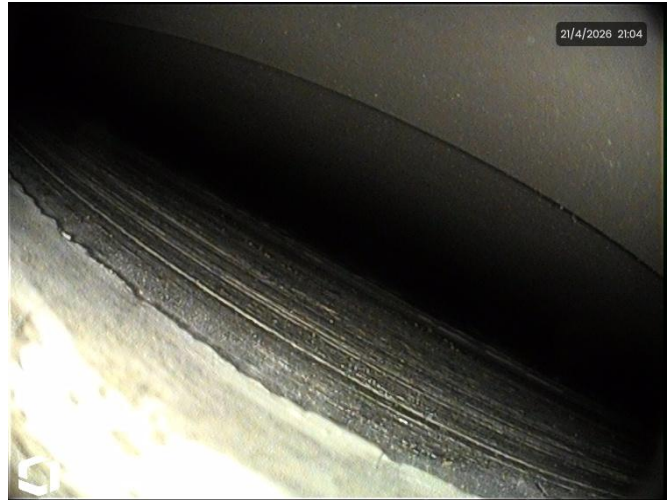
| Findings | Photo number |
|---|---|
| Debris, paint damage. | 26 |

**Photo 26: Coil 47. Debris and paint damage.**

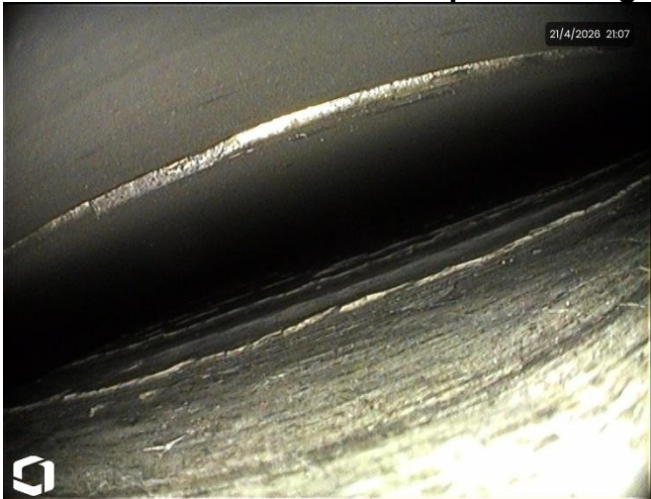
| Findings | Photo number |
|---|---|
| Debris, paint damage. | 27 |

**Photo 27: Coil 48. Debris and delamination.**

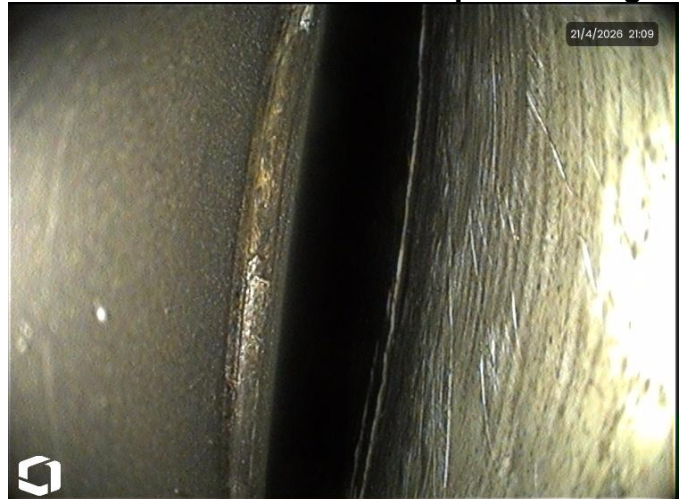
| Findings | Photo number |
|---|---|
| Debris, paint damage. | 28 |

**Photo 28: Coil 49. Debris and delamination.**

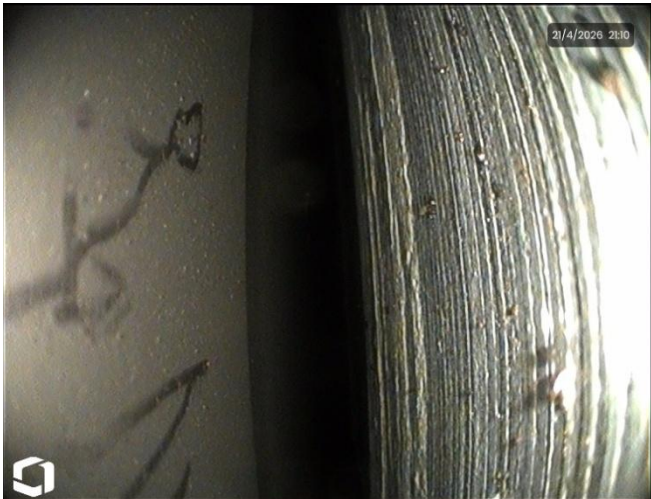
| Findings | Photo number |
|---|---|
| Debris, paint damage. | 29 |

**Photo 29: Coil 50. Debris and paint damage**

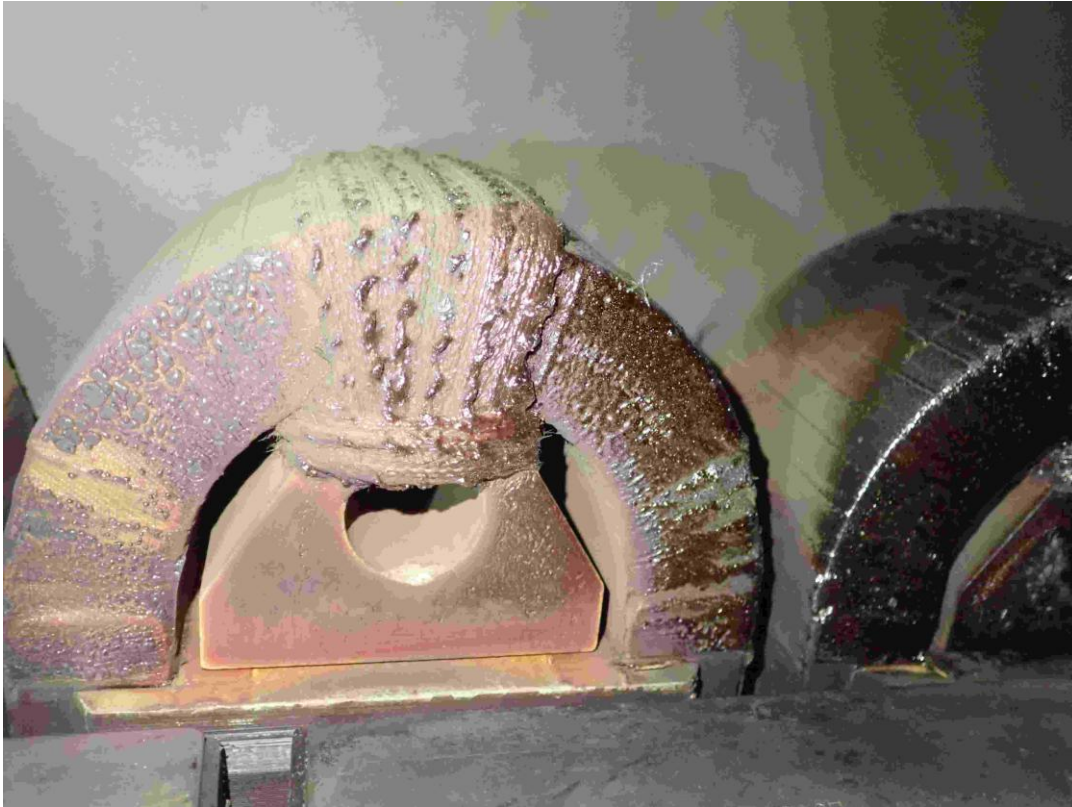
**Photo 1: Coil 23. Burned.**

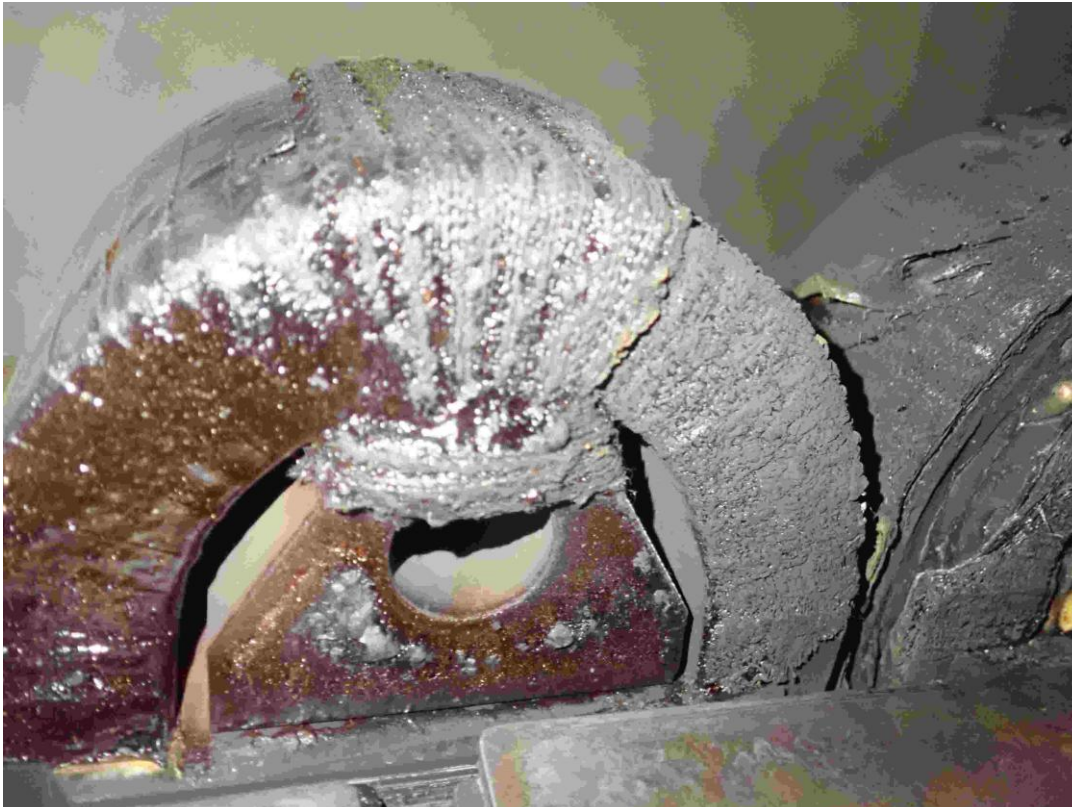
**Photo 2: Coil 24. Burned.**

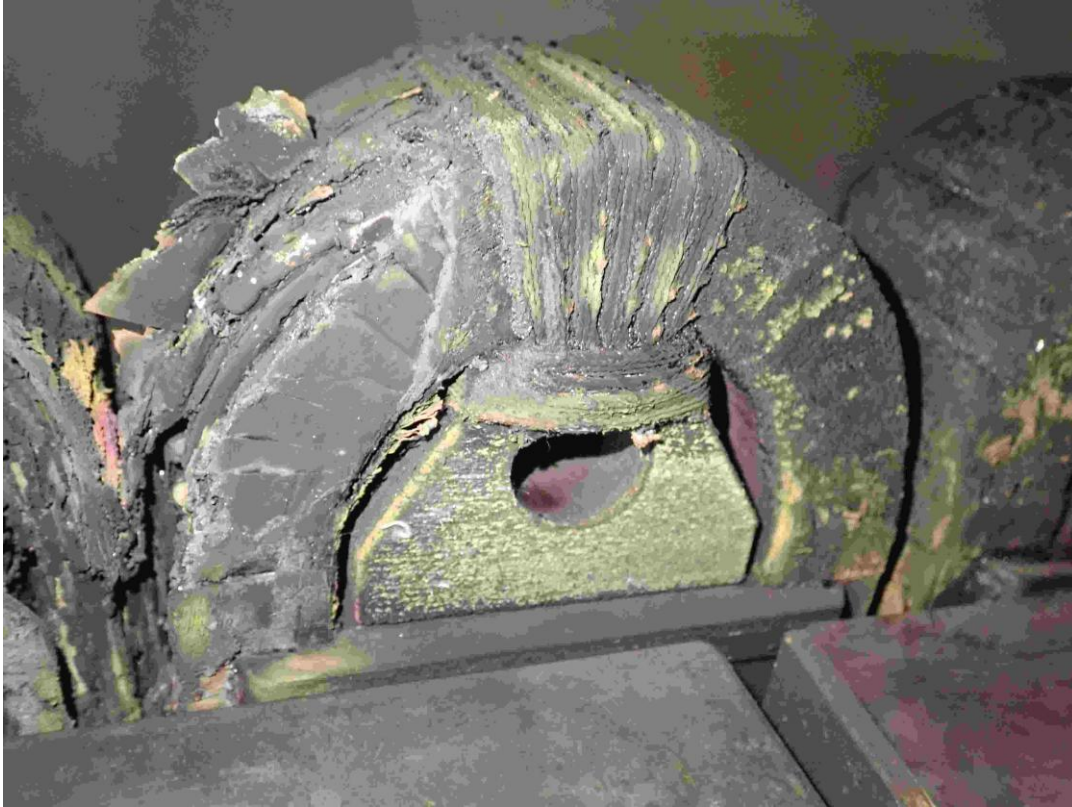
**Photo 3: Coil 26. Burned.**

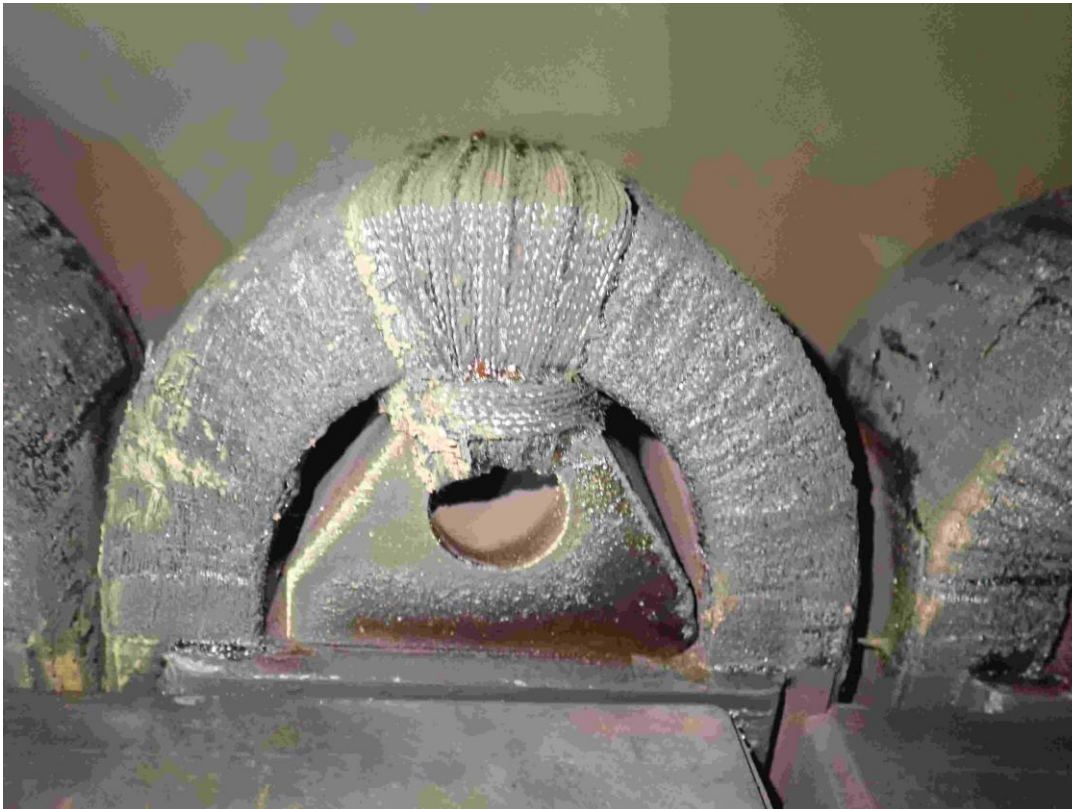
**Photo 4: Coil 27. Burned.**

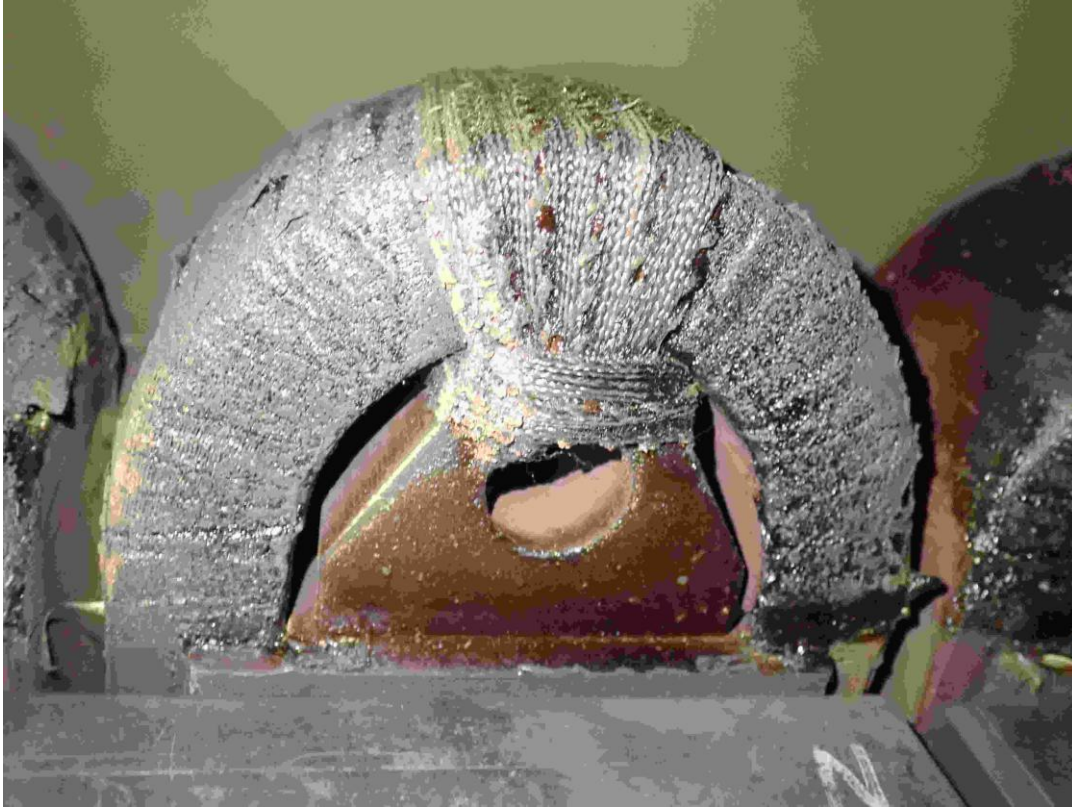
**Photo 5: Coil 28. Burned.**

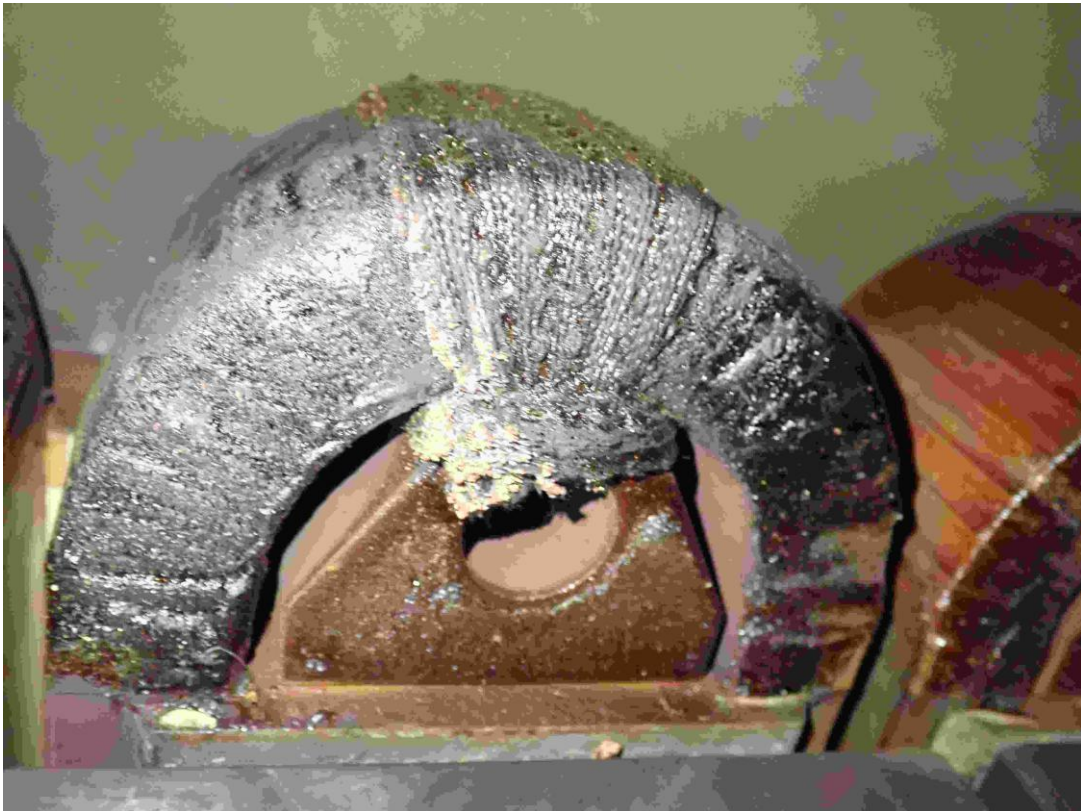
**Photo 6: Coil 29. Burned.**

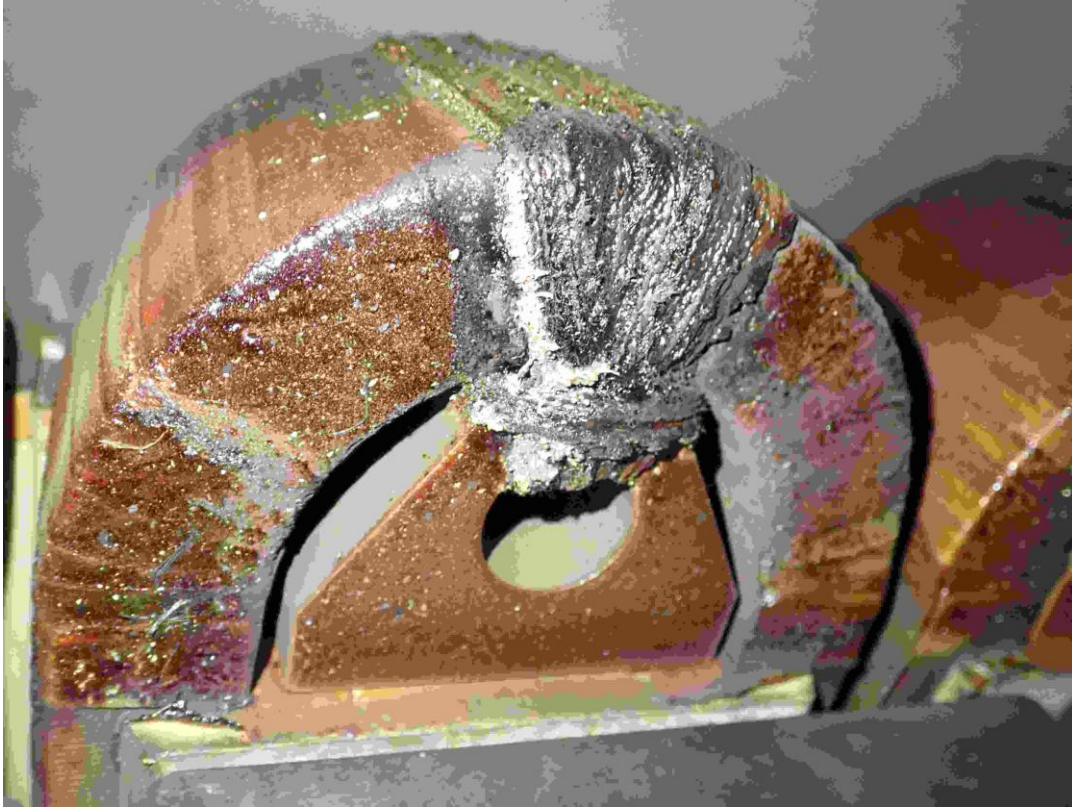
**Photo 7: Coil 30. Burned.**
