# Inspection Report

**Report Title:** Main gearbox

**MDE-RVI: Machine Diagnostic Engineering - Remote Visual Inspections**

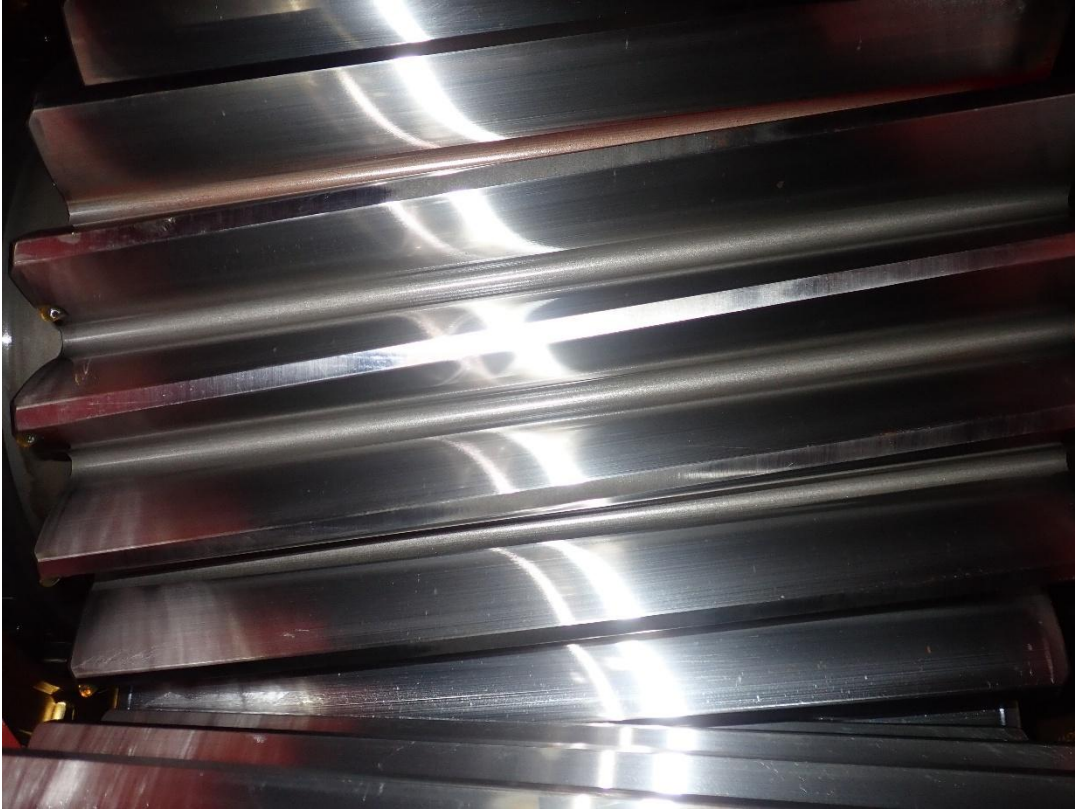
| Gear | Findings | Picture |
|---|---|---|
| A | No findings. | 1 |

**Photo 1:** Input shaft, pinion. **No deviations have been observed.**

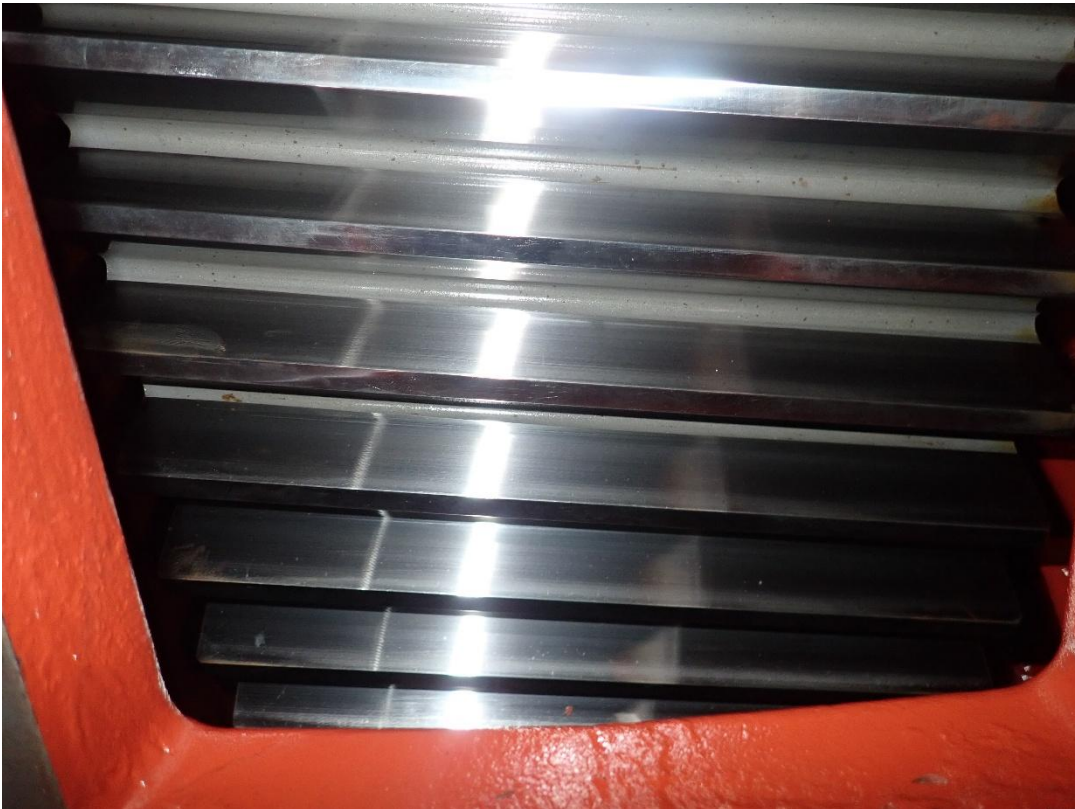
| Gear | Findings | Picture |
|---|---|---|
| B | No findings. | 2 |

**Photo 2:** Output shaft, gear. **No deviations have been observed.**

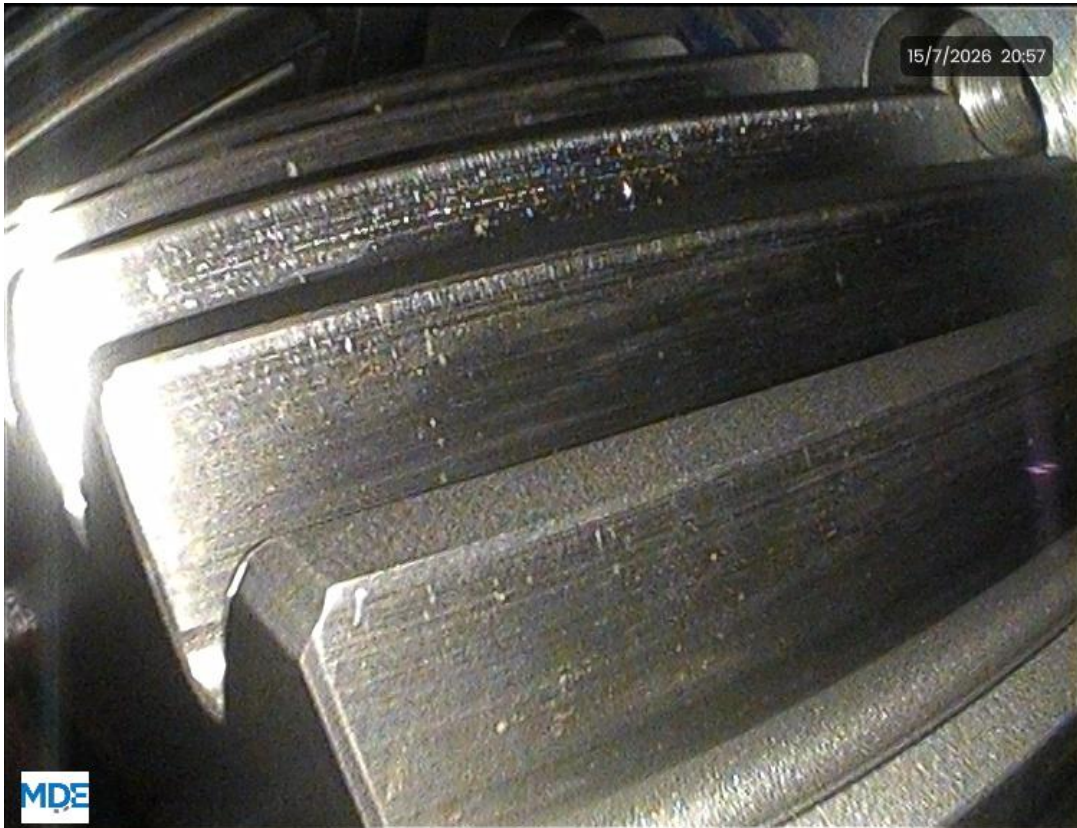
| Gear | Findings | Picture |
|---|---|---|
| C | No findings. | 3 |

**Photo 3: PTO gear. No deviations have been observed.**

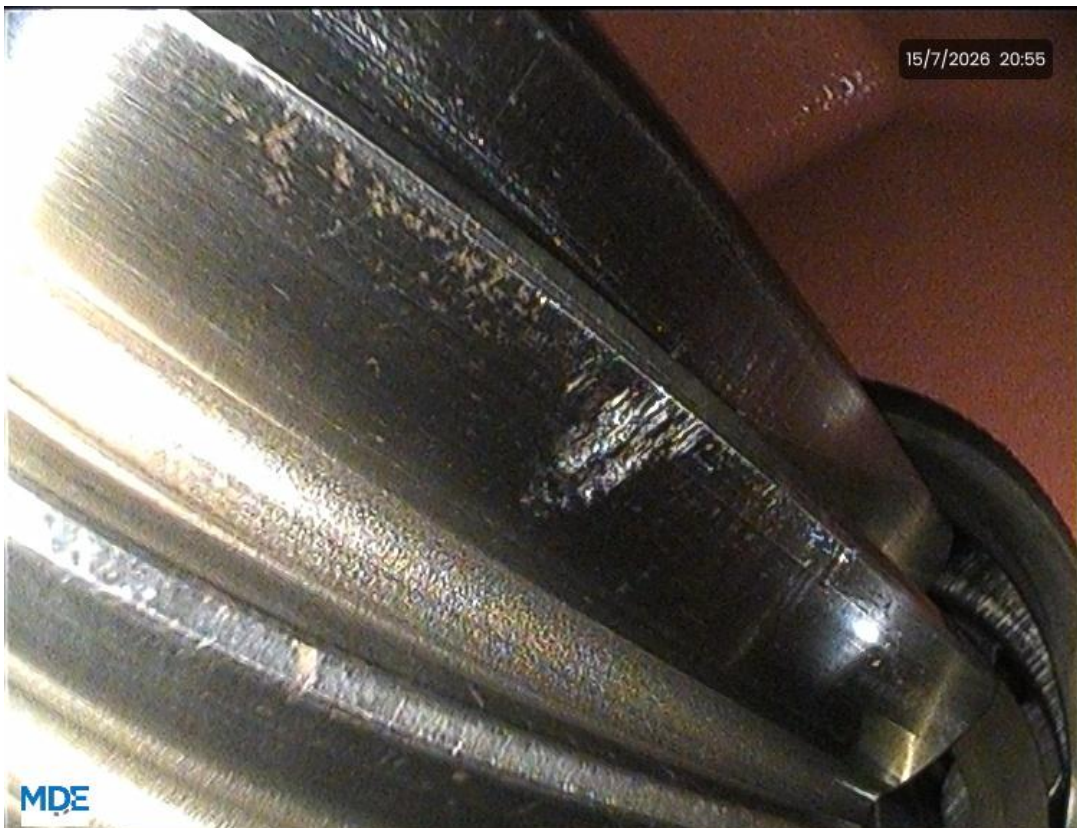
| Gear | Findings | Picture |
|---|---|---|
| D | Corrosion, scuffing. | 4 |

**Photo 4: PTO pinion. Minor corrosion and minor scuffing have been observed.**

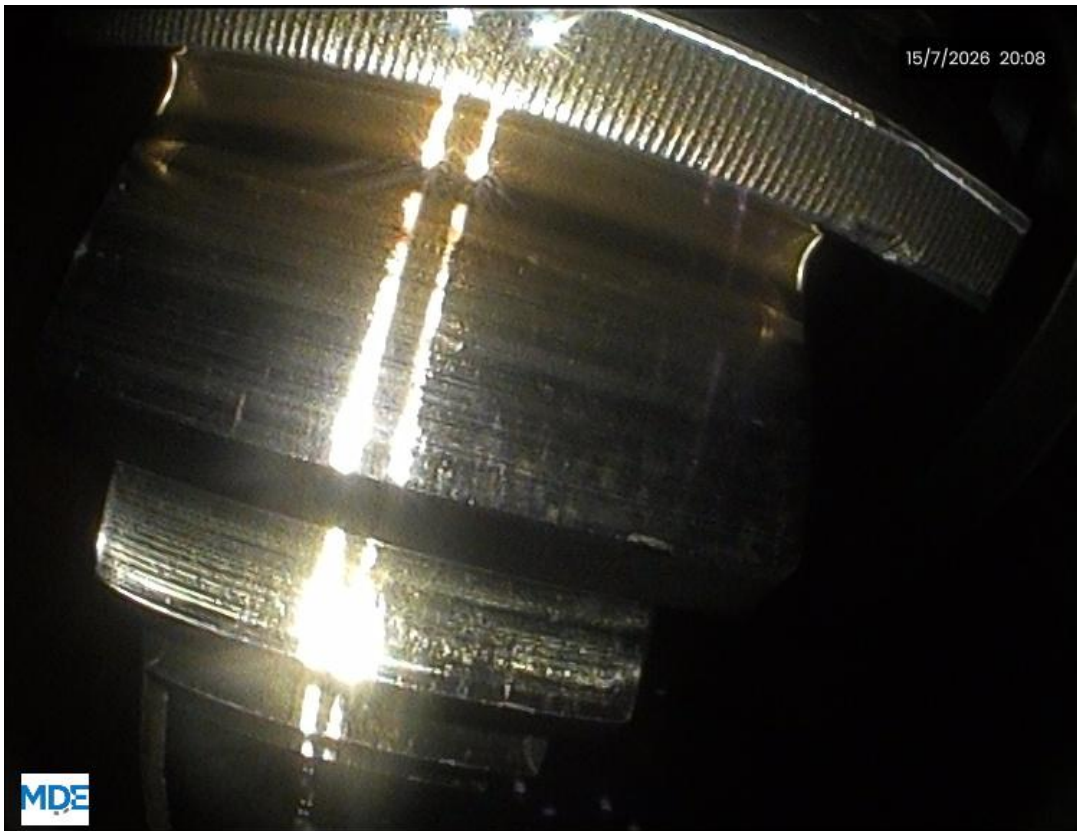
| Gear | Findings | Picture |
|---|---|---|
| E | No findings. | 5 |

**Photo 5: Oil pump gear. No deviations have been observed.**

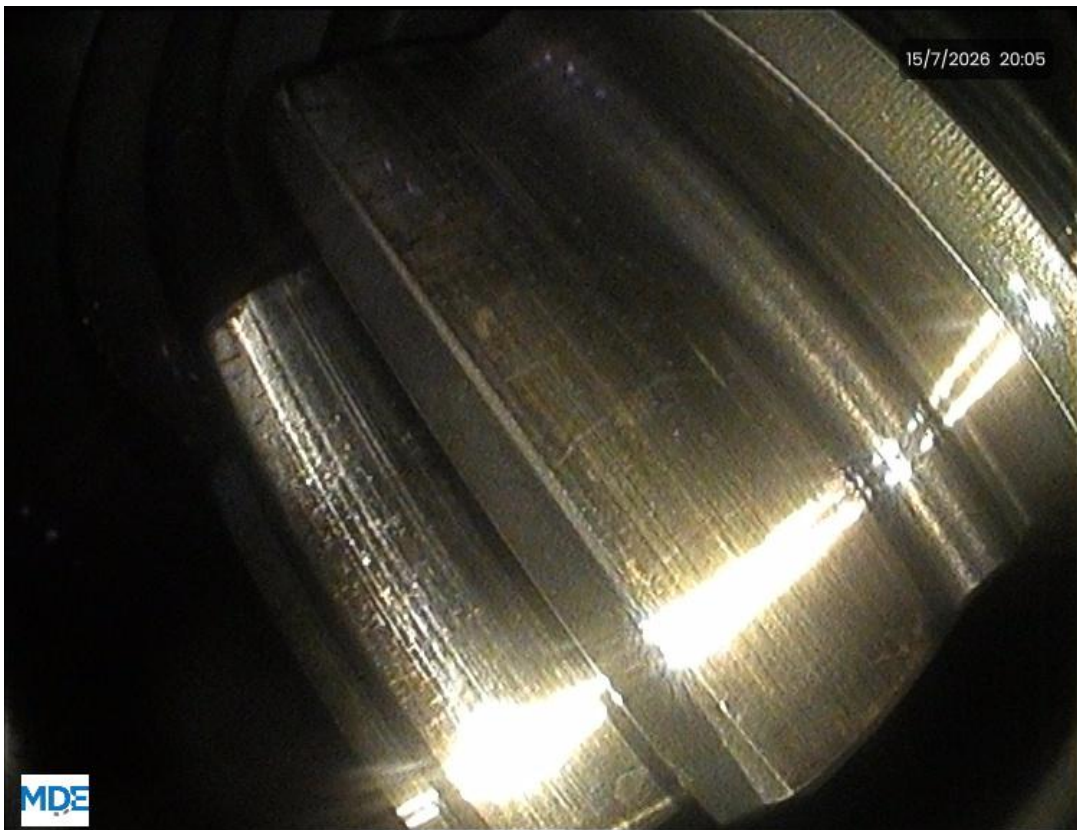
| Gear | Findings | Picture |
|---|---|---|
| F | No findings. | 6 |

**Photo 6: Oil pump pinion. No deviations have been observed.**

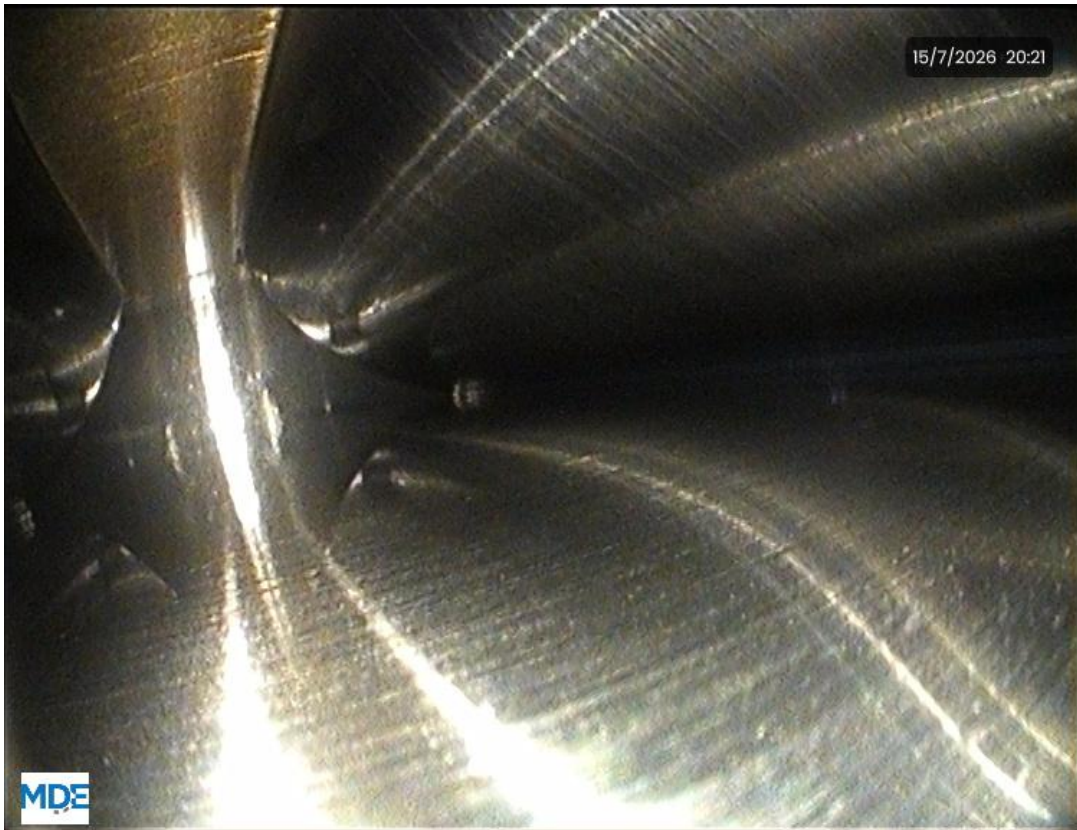
| Bearing | Not visible. | - |
|---|---|---|
| 1 | No findings. | 1 |

**Photo 1:** Bearing input shaft, driven end. **No deviations have been observed.**

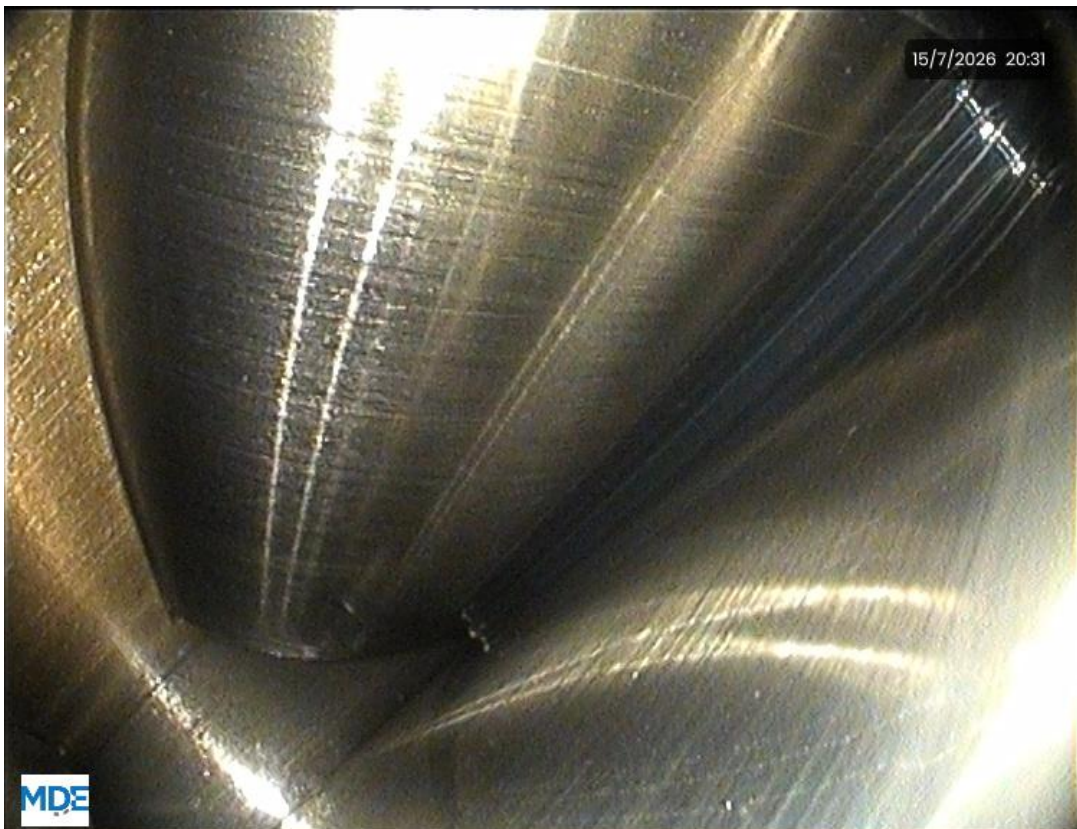
| Bearing | Not visible. | - |
|---|---|---|
| 2 | No findings. | 2 |

**Photo 2:** Bearing input shaft, mid, driven end. **No deviations have been observed.**

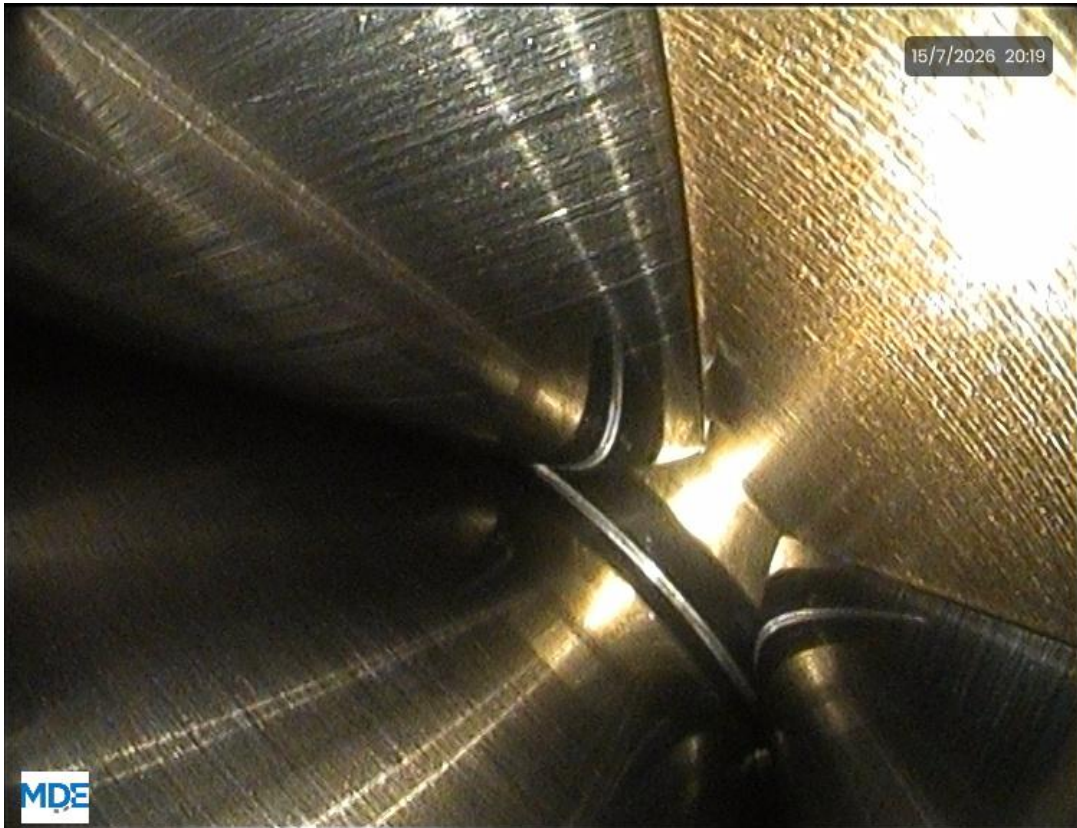
**Photo 3:** Input bearing, mid, mid. **No deviations have been observed.**

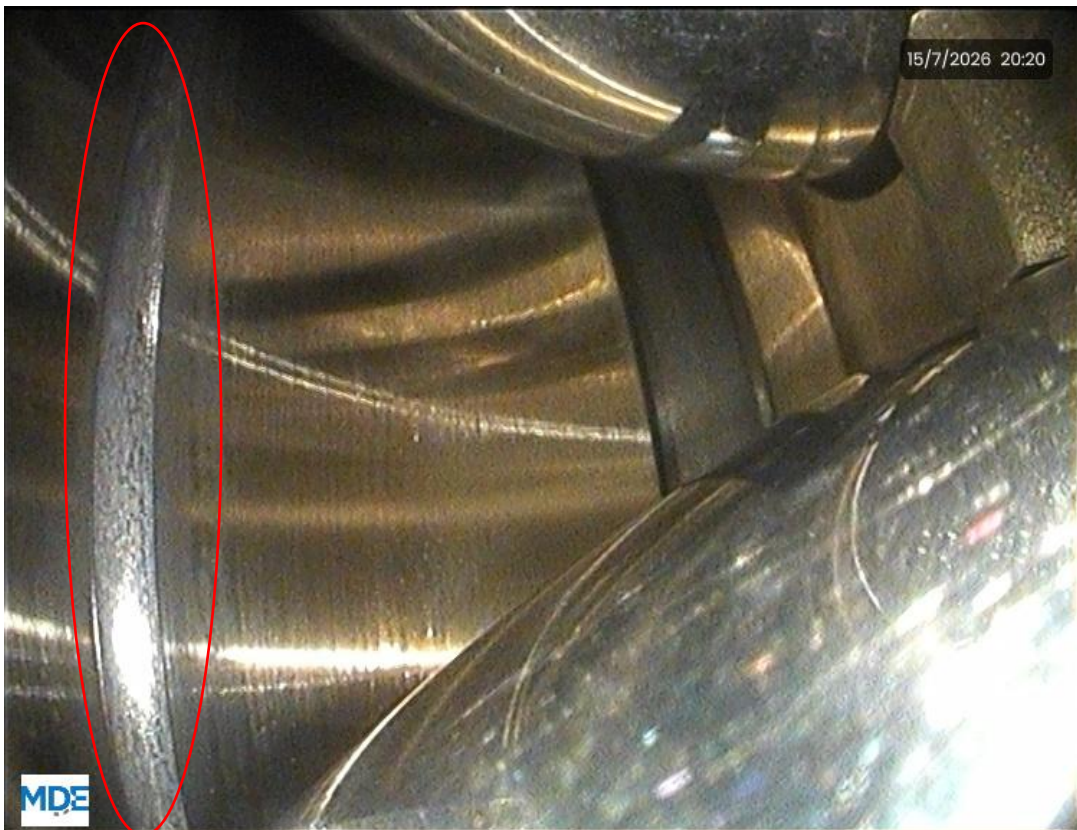
| Bearing | Not visible. | - |
|---|---|---|
| 5 | No findings. | 4 |

**Photo 4:** Input bearing, **No deviations have been observed.**

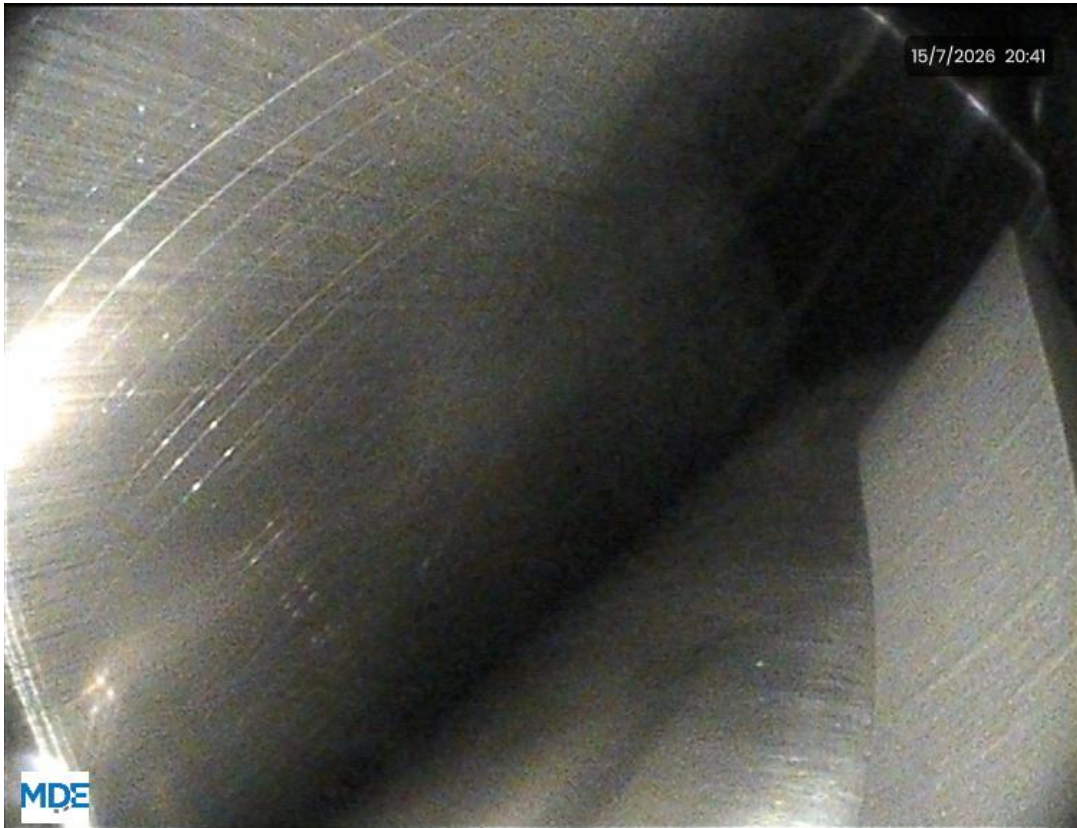
| Bearing | Not visible. | - |
|---|---|---|
| 7 | No findings. | 5 |

**Photo 5:** Output shaft, driven end. **No deviations have been observed.**

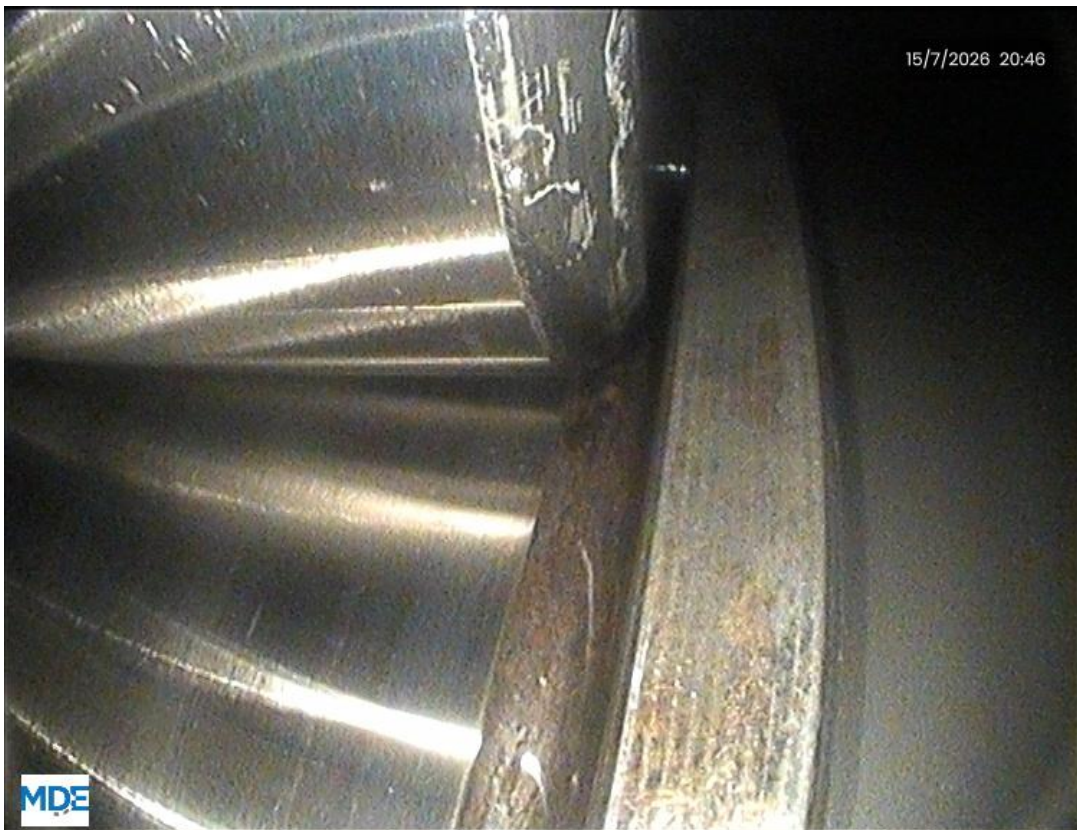
| Bearing | Not visible. | - |
|---|---|---|
| 8 | No findings. | 6 |

**Photo 6:** Output shaft, non-driven end. **No deviations have been observed.**

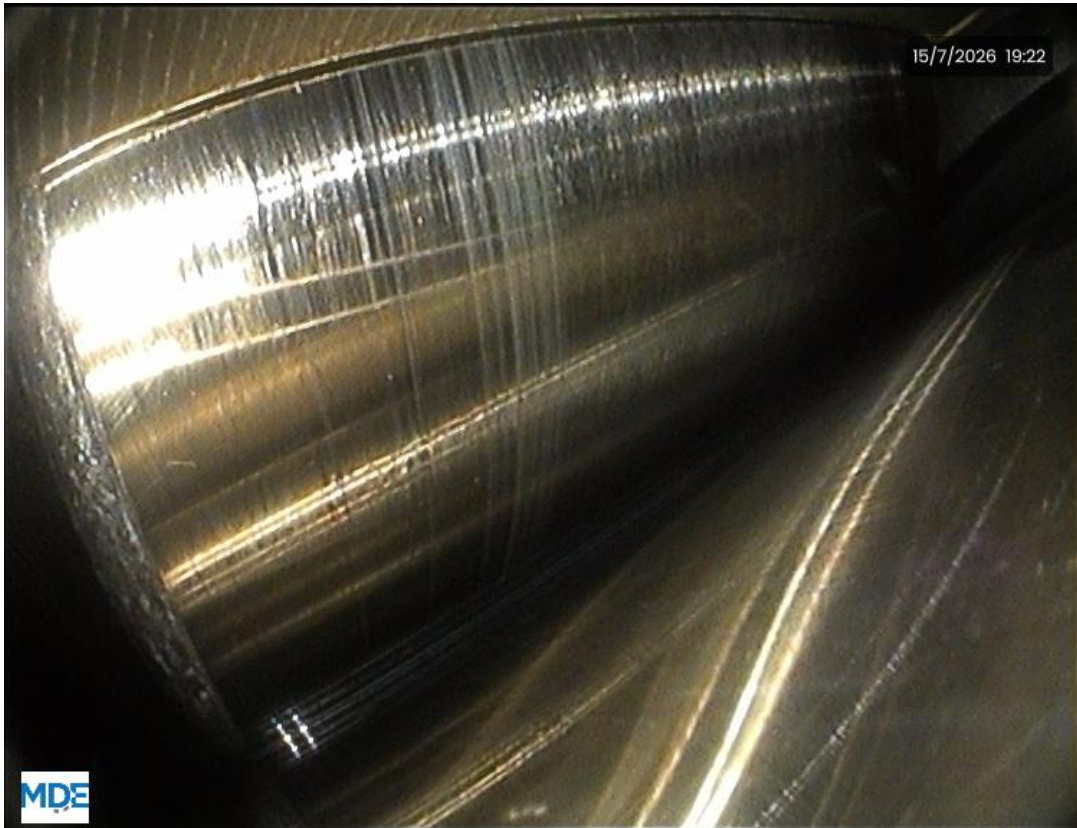
| Bearing | Not visible. | - |
|---|---|---|
| 9 | No findings. | 7 |

**Photo 7: PTO, driven end. No deviations have been observed.**

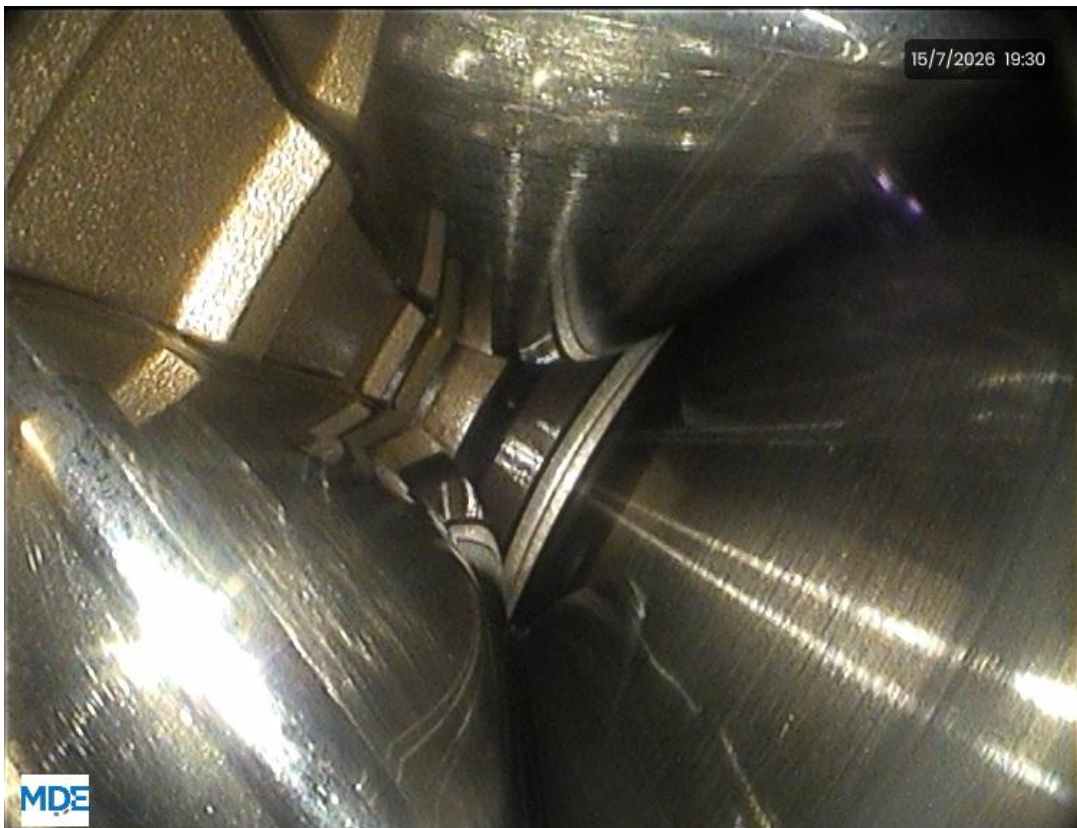
| Bearing | Not visible. | - |
|---|---|---|
| 10 | No findings. | 8 |

**Photo 8: PTO, mid, driven end. No deviations have been observed.**

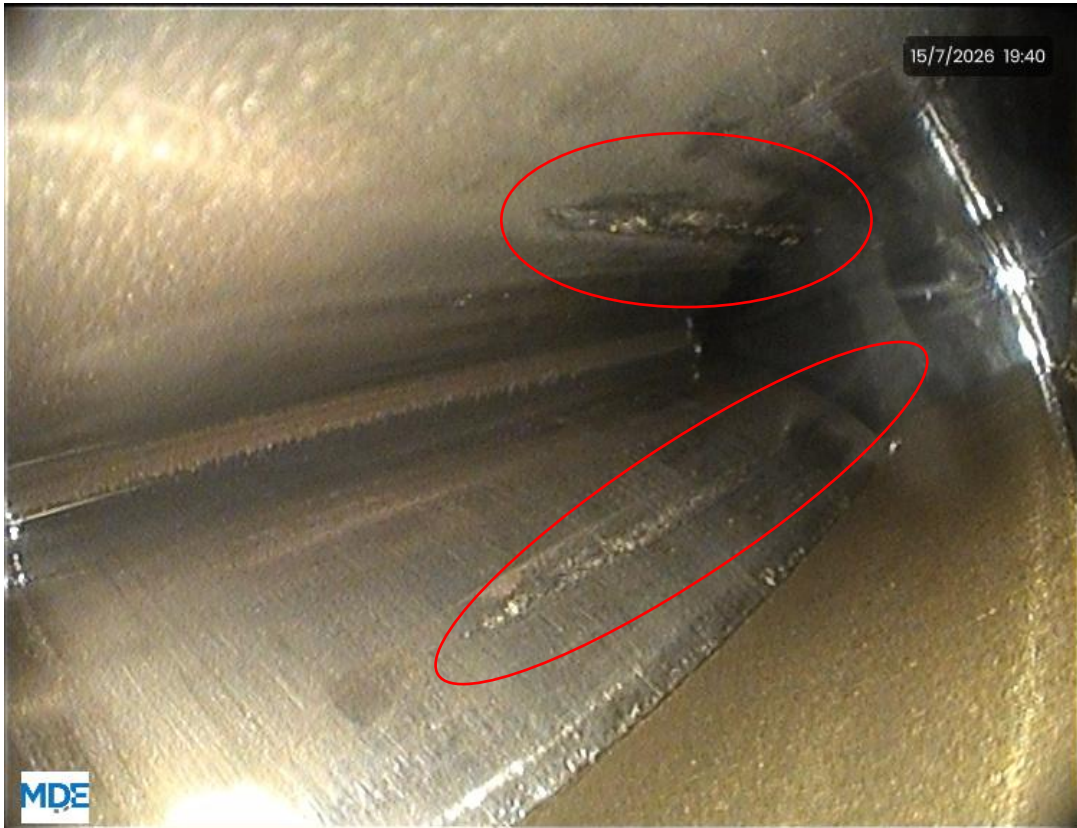
| Bearing | Not visible. | - |
|---|---|---|
| 11 | Pitting | 9 |

False brinelling damage was observed on the PTO mid bearing at the drive end (DE). False brinelling is a wear mechanism caused by small oscillatory movements and vibration under static or lightly loaded conditions. The resulting damage appears similar to true brinelling; however, the damage mechanism is different.

True brinelling is characterized by permanent plastic deformation of the raceway caused by a single overload event. False brinelling, on the other hand, develops gradually due to repeated micro-movements between rolling elements and raceways. These movements displace the lubricant from the contact area, resulting in metal-to-metal contact, wear, and oxidation of wear particles. The generated debris may become abrasive and further accelerate the deterioration process.

**Photo 9:** PTO mid, mid, non-driven end. **Pitting, false brinelling have been observed.**

To prevent further deterioration and reduce the risk of gearbox damage, the following actions are recommended:

1. Replace the PTO shaft bearings.
2. Perform periodic visual borescope inspections on an annual basis.
3. Following gearbox overhaul or bearing replacement, perform vibration measurements to verify the condition of all bearings and gears and to confirm correct assembly and alignment.

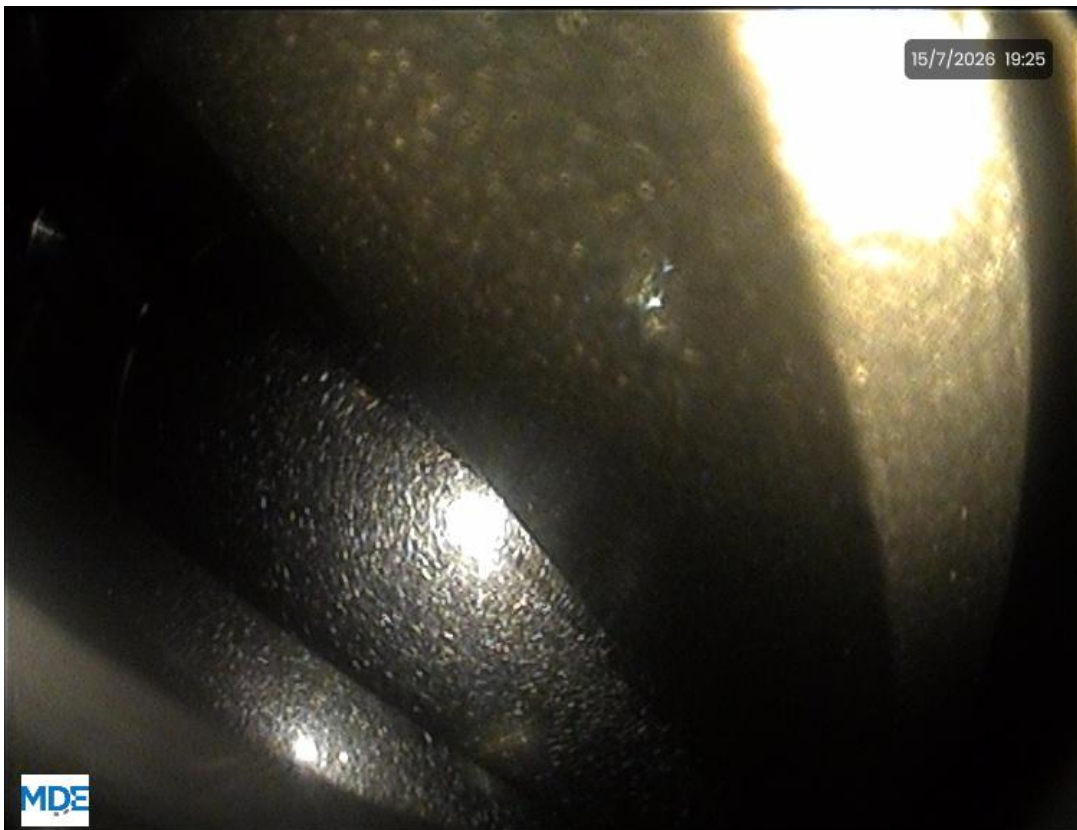
| Bearing | Not visible. | - |
|---|---|---|
| 12 | No findings. | 10 |

**Photo 10:** PTO ball bearing NDE. **No deviations have been observed.**

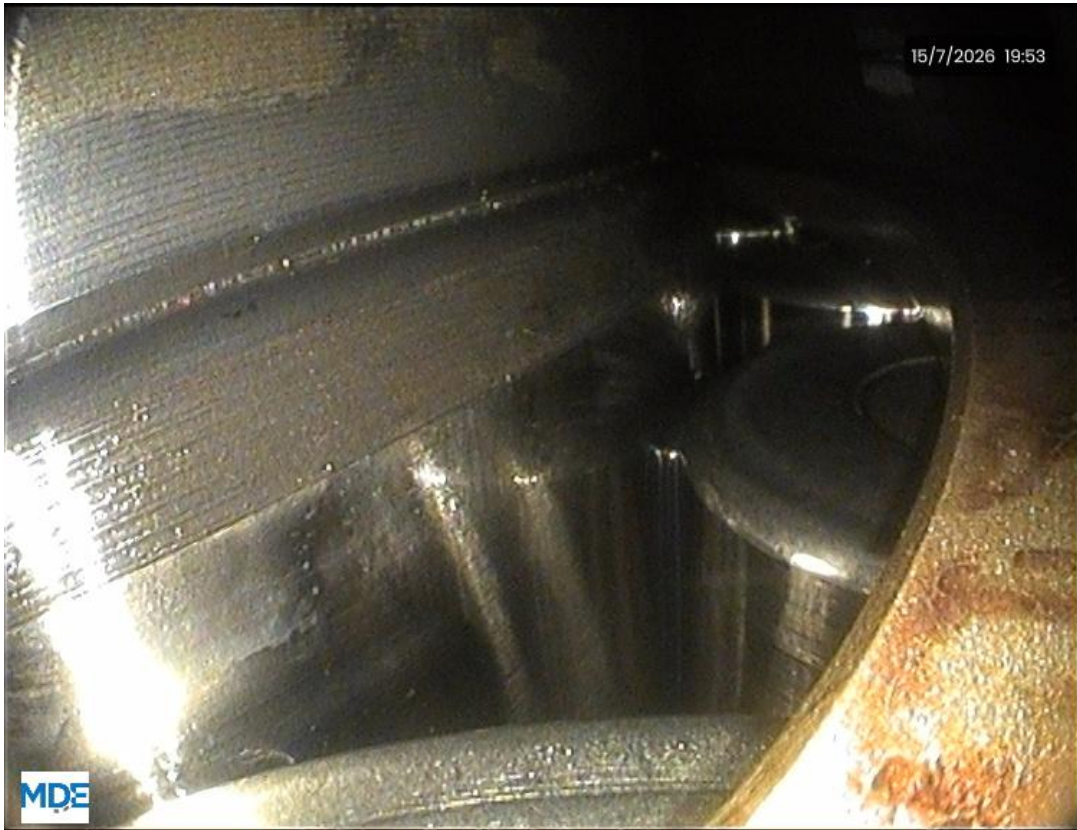
| Bearing | Not visible. | - |
|---|---|---|
| 13 | No findings. | 11 |

**Photo 11: PTO non-driven end. No deviations have been observed.**

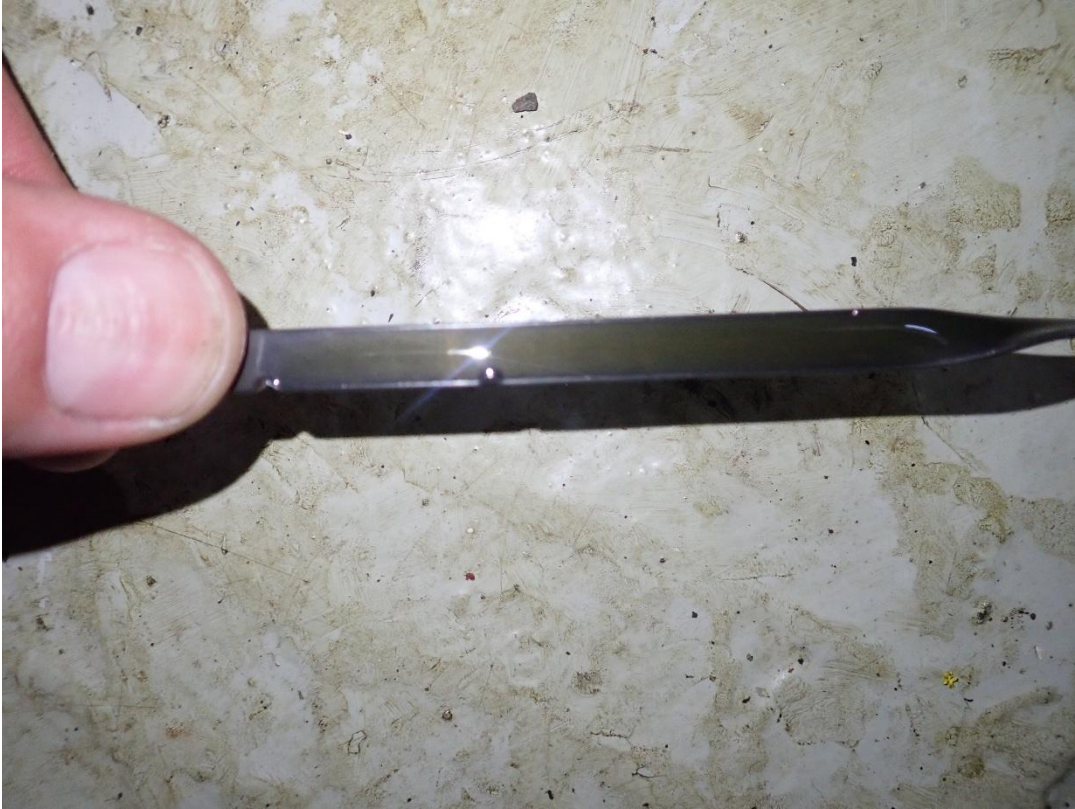
Photo 1, appendix 3: The oil level is at the prescribed operating level.  
 Photo 2, appendix 3: The input shaft shows no leakages.  
 Photo 3, appendix 3: The output shaft shows no leakages.  
 Photo 4, appendix 3: The input PTO shows no leakages.

**Photo 1: Dipstick. Oil is on the prescribed level.**

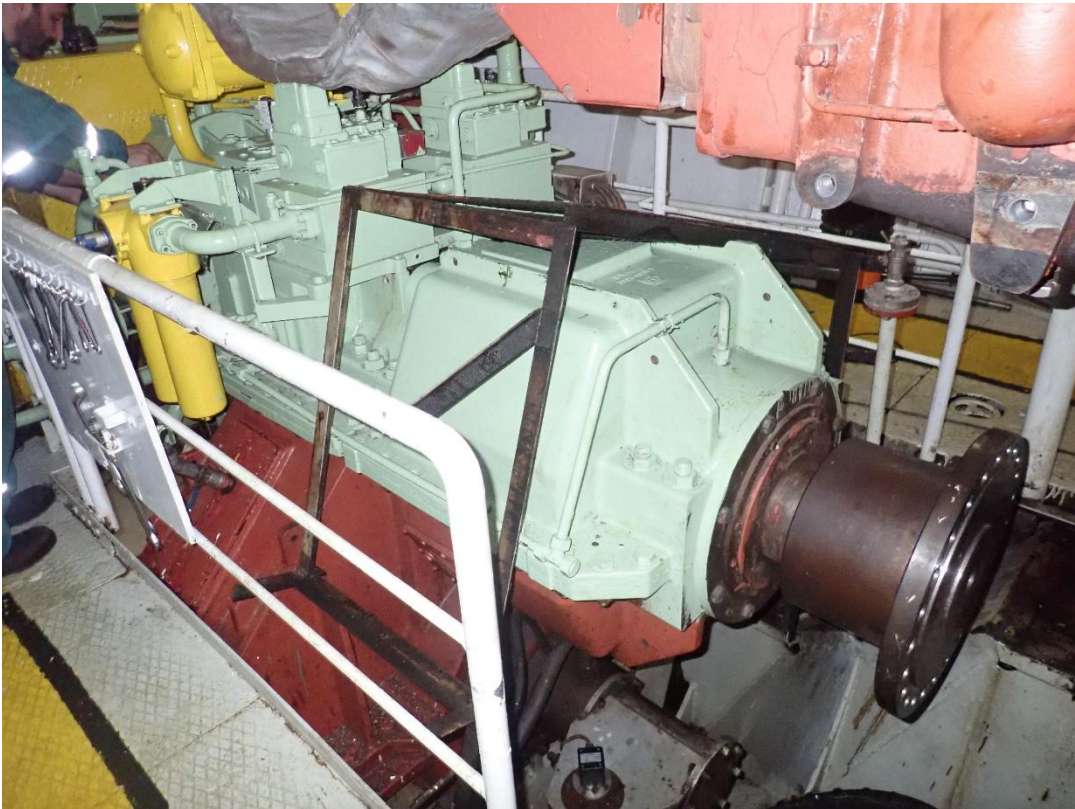
**Photo 2: Input shaft. No leakages have been observed.**

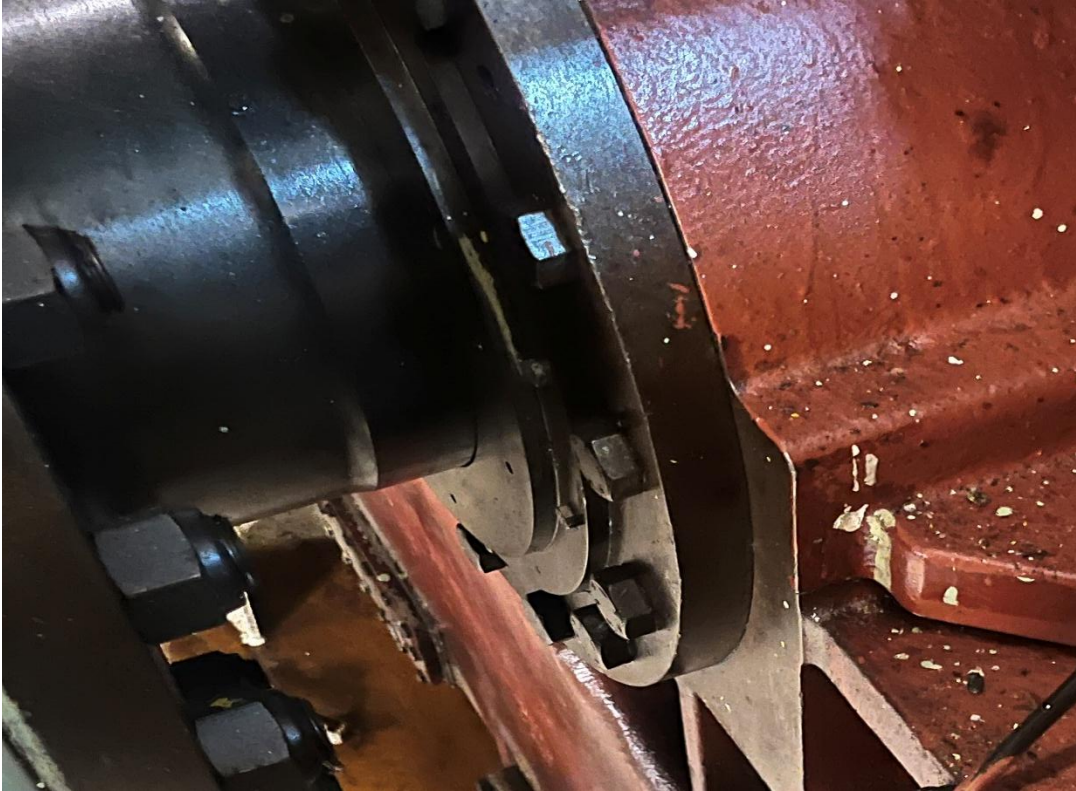
**Photo 3: Output shaft. No leakages have been observed.**

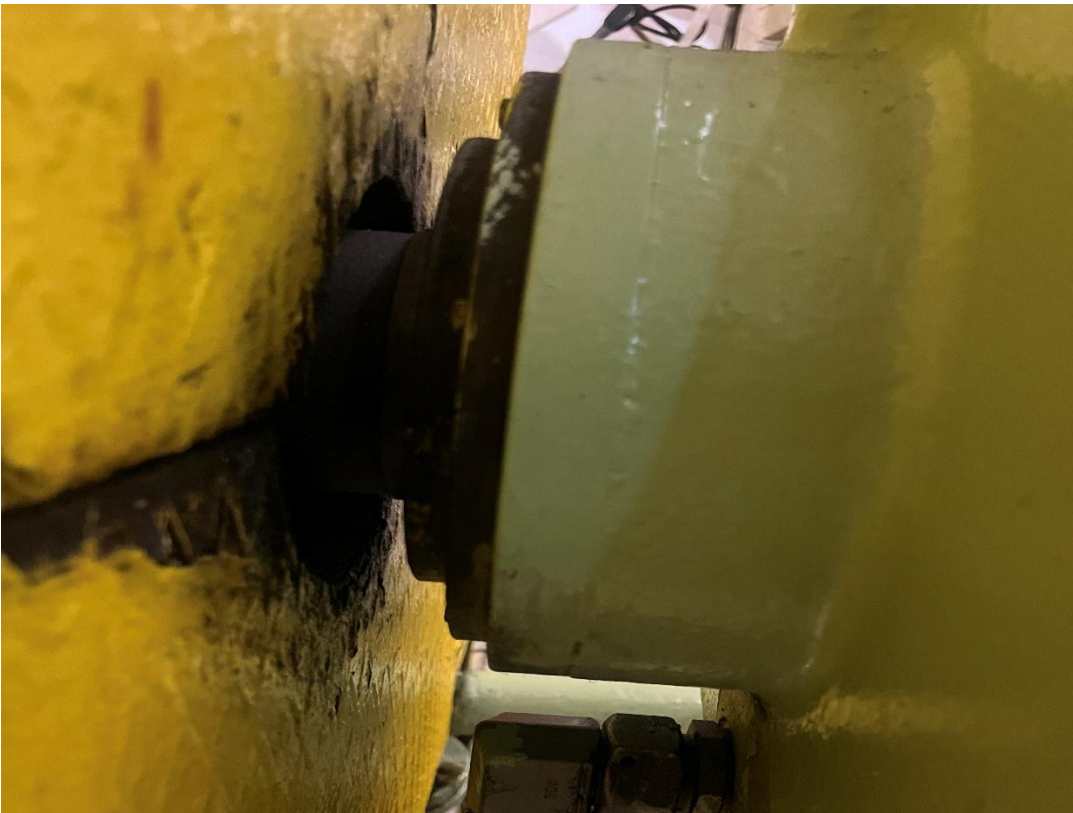
**Photo 4: PTO shaft. No leakages have been observed.**
