# Gearbox Inspection Report

| Gearbox S/N: | 7930000002263 |
| Gearbox type: | GPV510D |

This report presents the results of the visual inspection performed on the main gearbox of turbine located [REDACTED] the Netherlands. MDE-RVI was invited by [REDACTED] to carry out the above-mentioned activity to assess the condition of the gearbox.

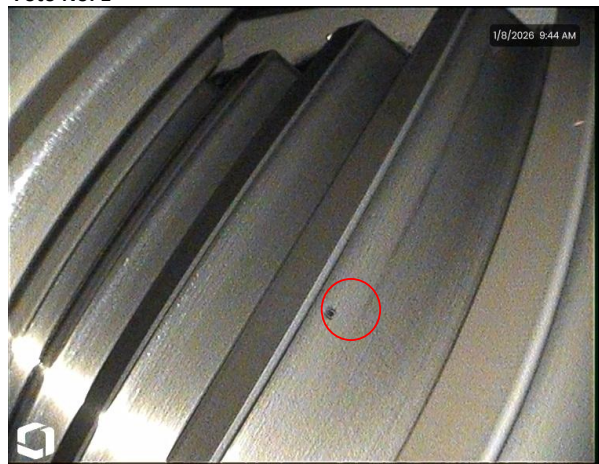
Foto No. 1

| 1.1.1 RG A1 - Ring gear |
| 09 - Indentations |
| Acceptable |
| Indentation has been observed. |

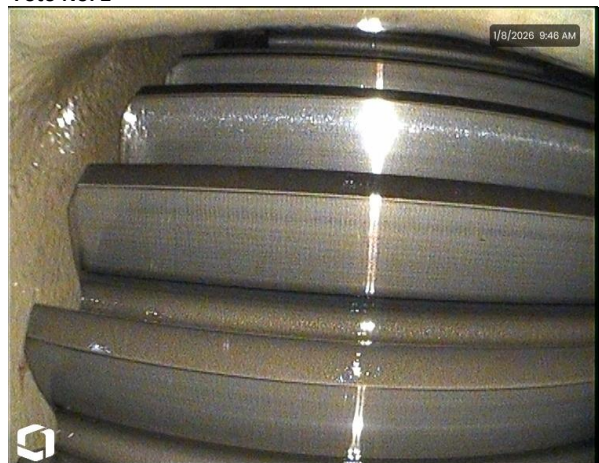
Foto No. 2

| 1.1.2 PW A1.1 - Planetary wheel |
| No excessive wear or damage has been observed. |

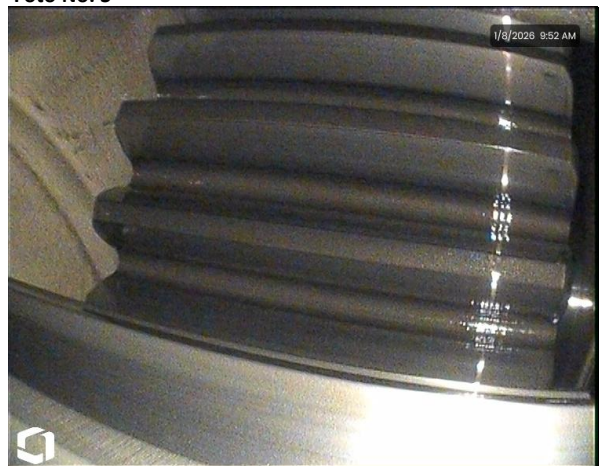
Foto No. 3

| 1.1.3 PW A1.2 - Planetary wheel |
| No excessive wear or damage has been observed. |

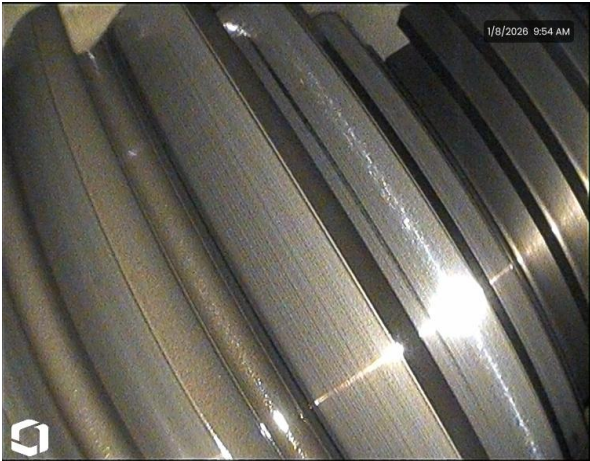
Foto No. 4

1.1.4 PW A1.3 - Planetary wheel

No excessive wear or damage has been observed.

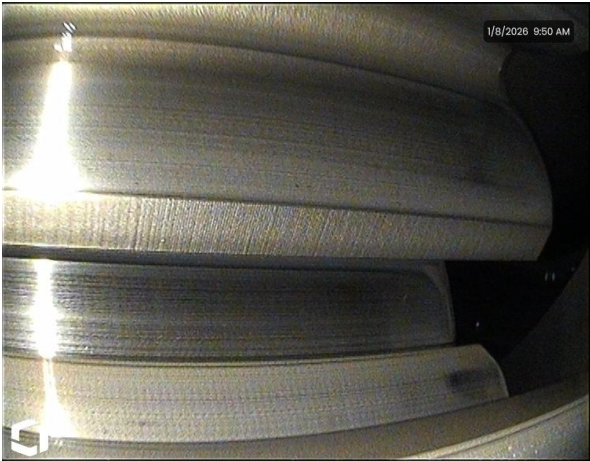
Foto No. 5

1.1.5 SU A1 - Sun pinion

No excessive wear or damage has been observed.

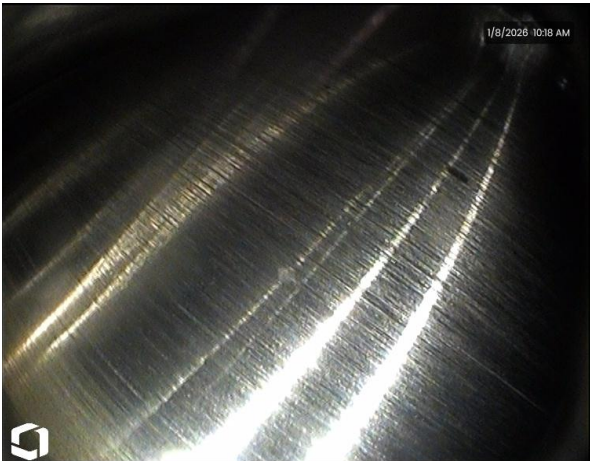
Foto No. 6

1.2.1 PC A1 R - Planet carrier bearing

No excessive wear or damage has been observed.

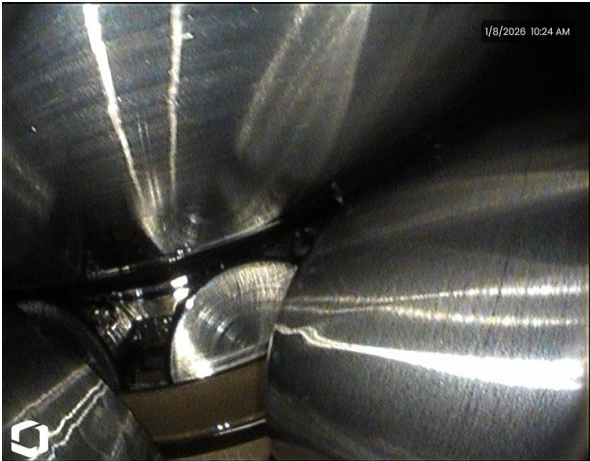
Foto No. 7

1.2.3 PB A1.1 R - Planet bearing

No excessive wear or damage has been observed.

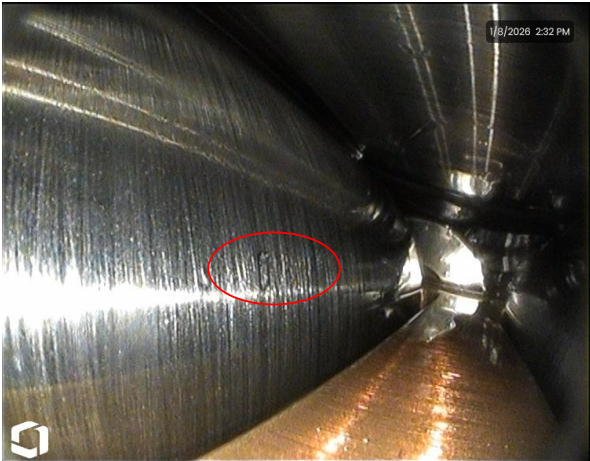
Foto No. 8

1.2.4 PB A1.1 G - Planet bearing

11 - Indentations

Acceptable

Indentation has been observed.

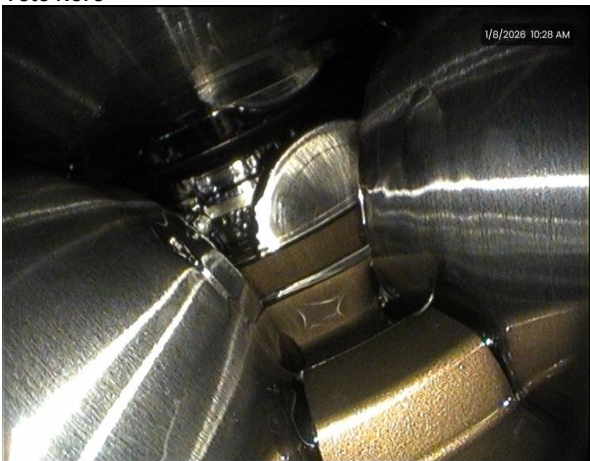
Foto No. 9

1.2.5 PB A1.2 R - Planet bearing

No excessive wear or damage has been observed.

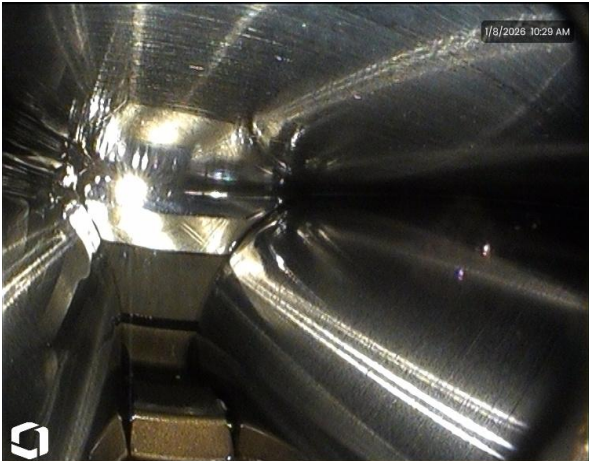
Foto No. 10

1.2.6 PB A1.2 G - Planet bearing

No excessive wear or damage has been observed.

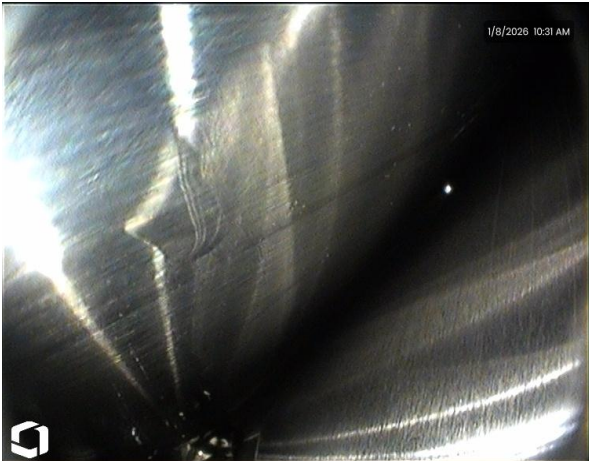
Foto No. 11

1.2.7 PB A1.3 R - Planet bearing

No excessive wear or damage has been observed.

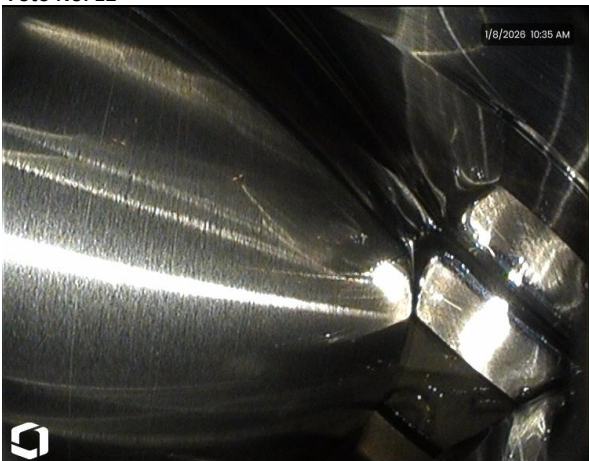
Foto No. 12

1.2.8 PB A1.3 G - Planet bearing

No excessive wear or damage has been observed.

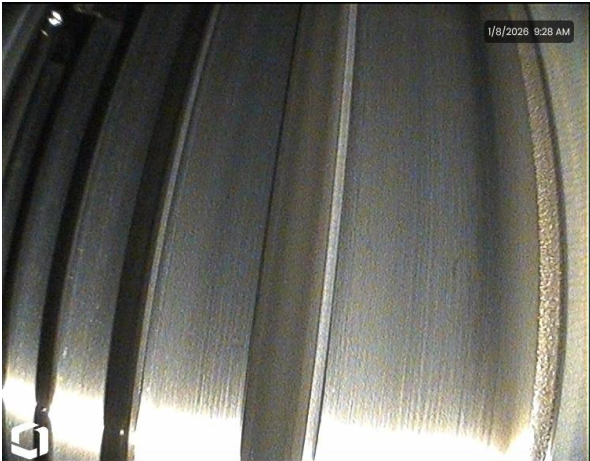
Foto No. 13

2.1.1 RG A2 - Ring gear

No excessive wear or damage has been observed.

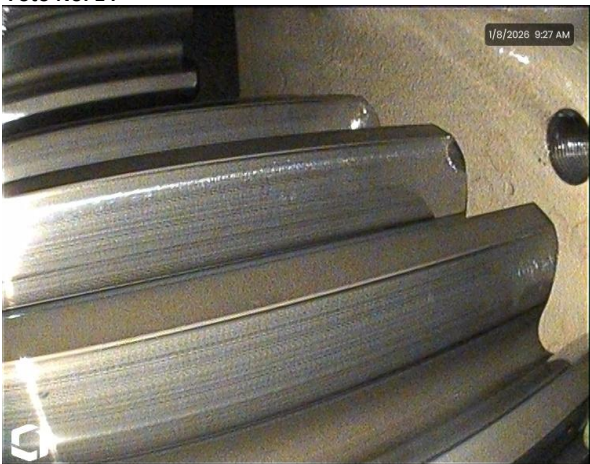
Foto No. 14

2.1.2 PW A2.1 - Planetary wheel

No excessive wear or damage has been observed.

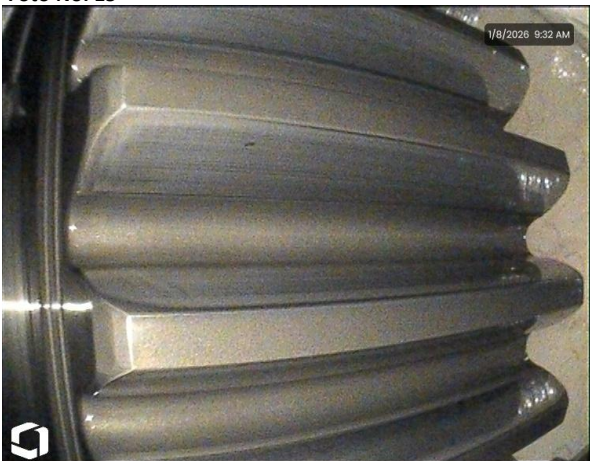
Foto No. 15

2.1.3 PW A2.2 - Planetary wheel

No excessive wear or damage has been observed.

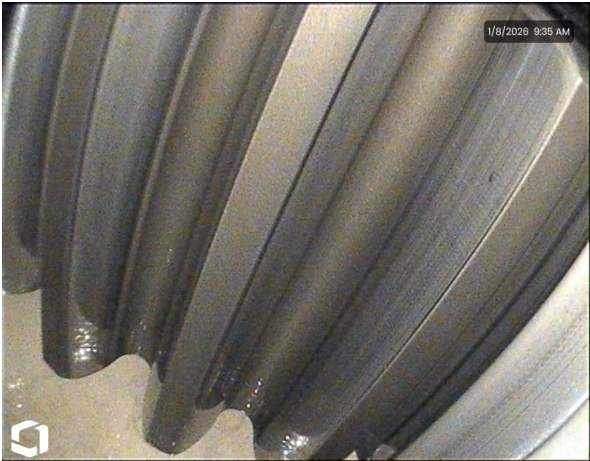
Foto No. 16

2.1.4 PW A2.3 - Planetary wheel

No excessive wear or damage has been observed.

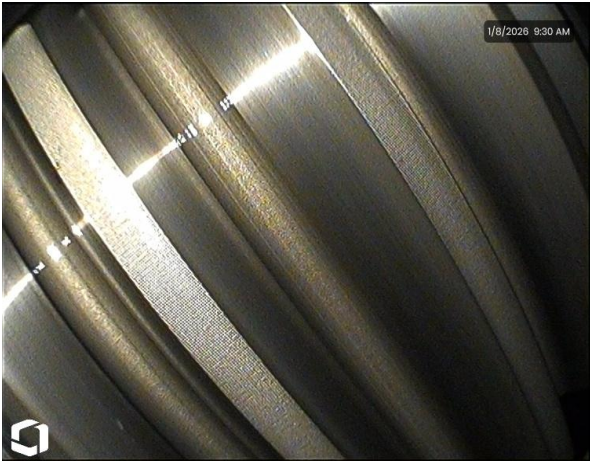
Foto No. 17

2.1.5 SU A2 - Sun pinion

No excessive wear or damage has been observed.

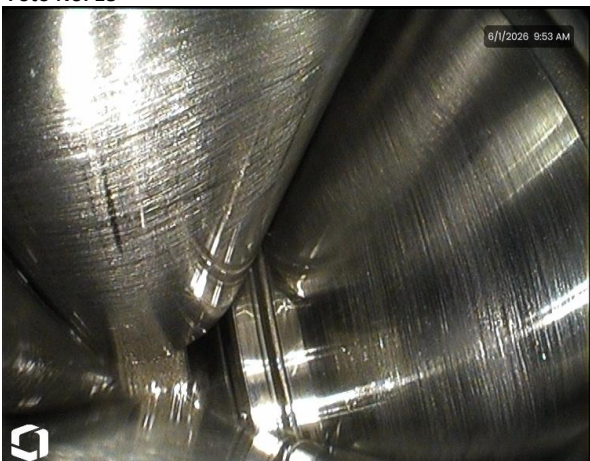
Foto No. 18

2.2.2 PC A2 G - Planet carrier bearing

No excessive wear or damage has been observed.

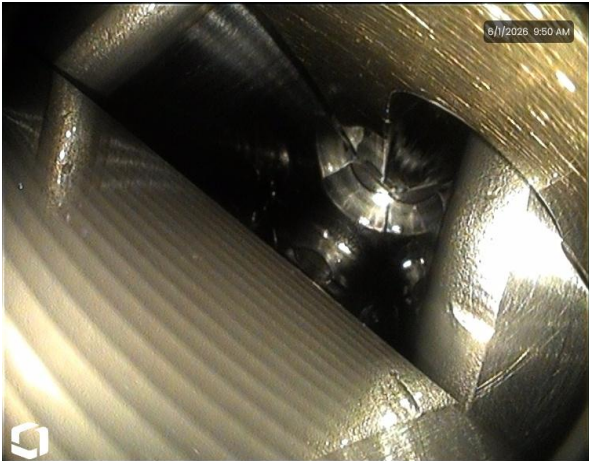
Foto No. 19

2.2.3 PB A2.1 R - Planet bearing

No excessive wear or damage has been observed.

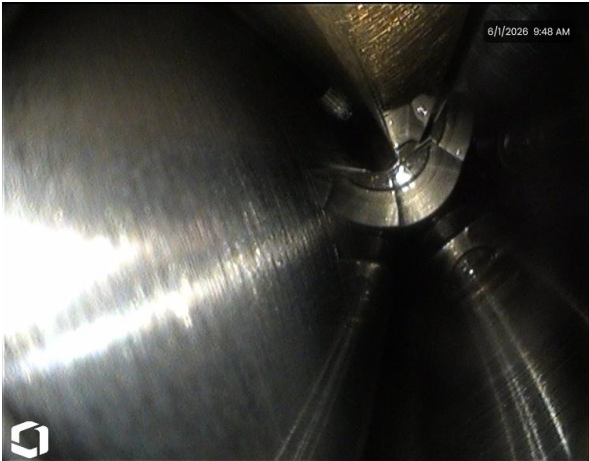
Foto No. 20

2.2.4 PB A2.1 G - Planet bearing

No excessive wear or damage has been observed.

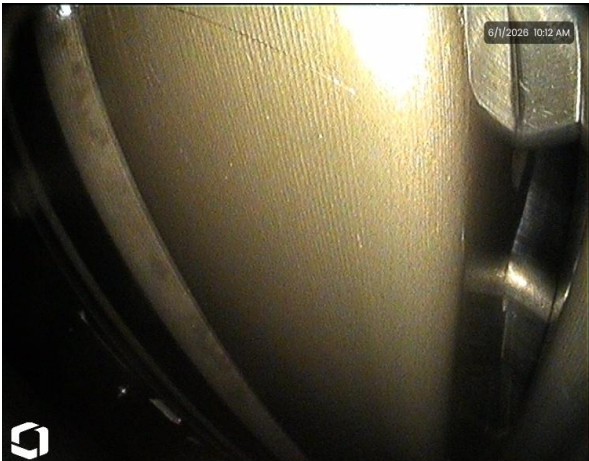
Foto No. 21

2.2.5 PB A2.2 R - Planet bearing

No excessive wear or damage has been observed.

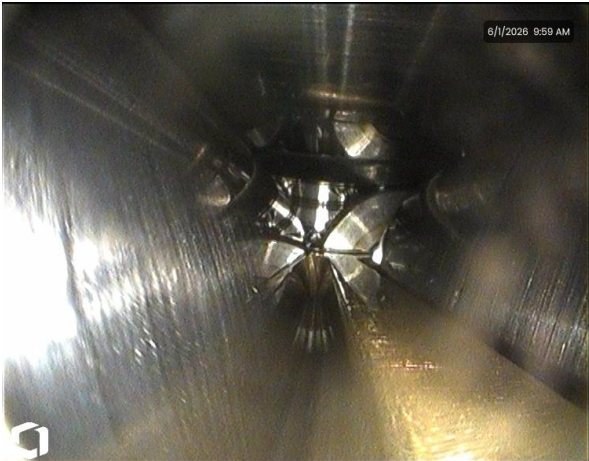
Foto No. 22

2.2.6 PB A2.2 G - Planet bearing

No excessive wear or damage has been observed.

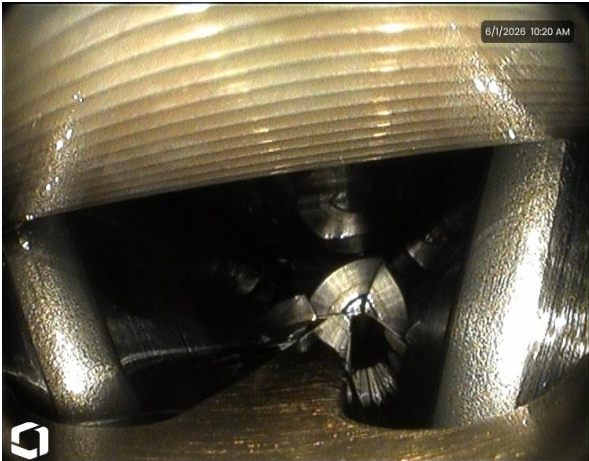
Foto No. 23

2.2.7 PB A2.3 R - Planet bearing

No excessive wear or damage has been observed.

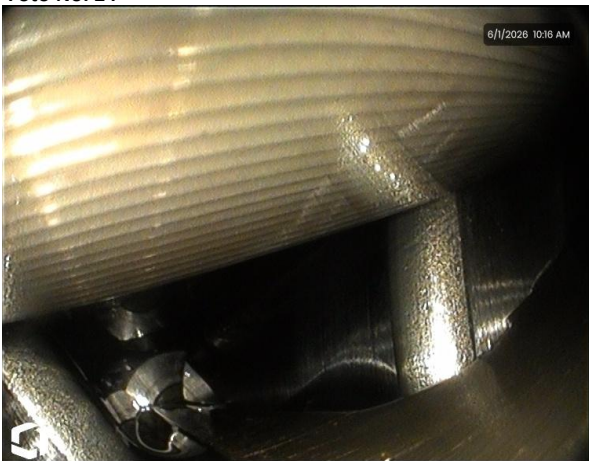
Foto No. 24

2.2.8 PB A2.3 G - Planet bearing

No excessive wear or damage has been observed.

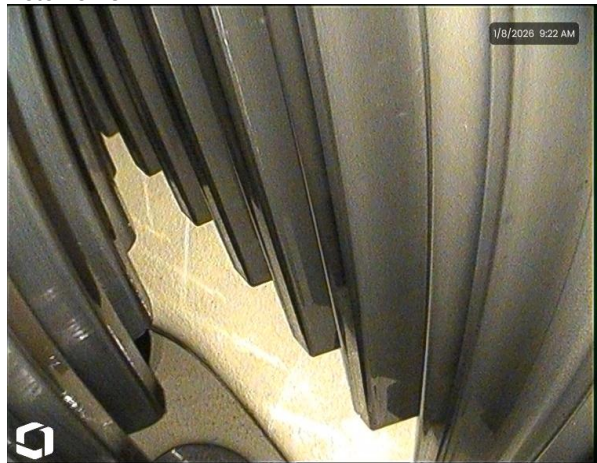
Foto No. 25

3.1.1 RG B - Ring gear

No excessive wear or damage has been observed.

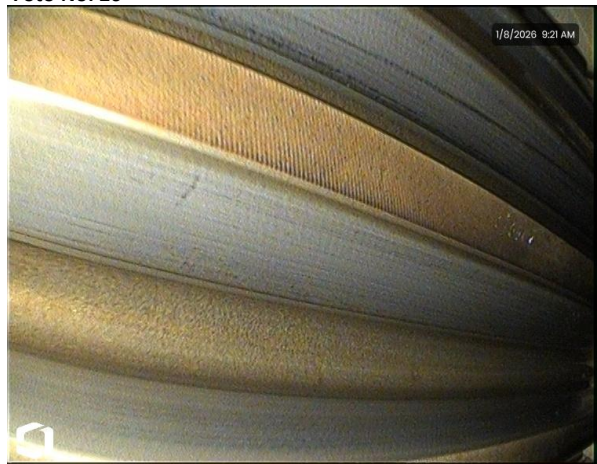
Foto No. 26

3.1.2 PW B.1 - Planetary wheel

No excessive wear or damage has been observed.

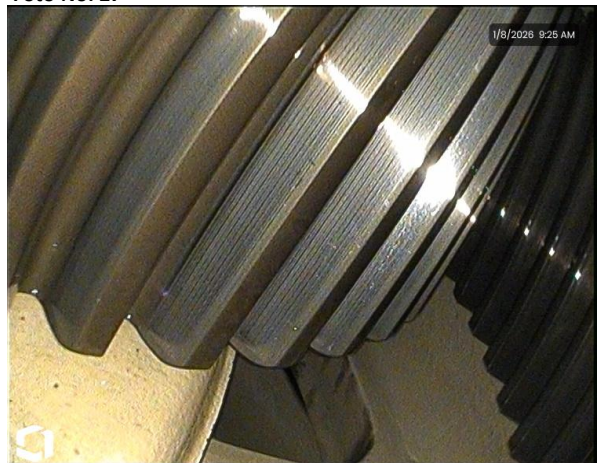
Foto No. 27

3.1.3 PW B.2 - Planetary wheel

No excessive wear or damage has been observed.

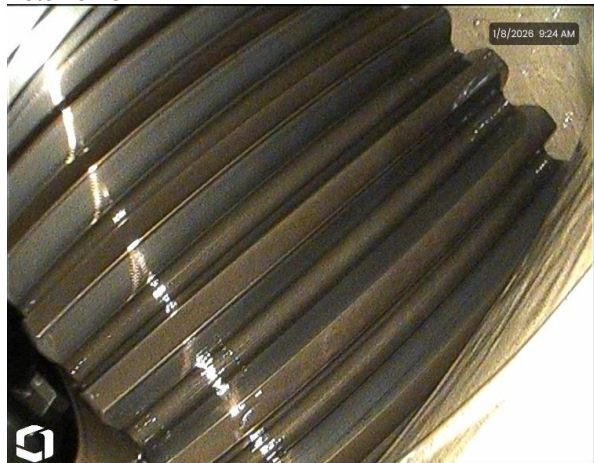
Foto No. 28

3.1.4 PW B.3 - Planetary wheel

No excessive wear or damage has been observed.

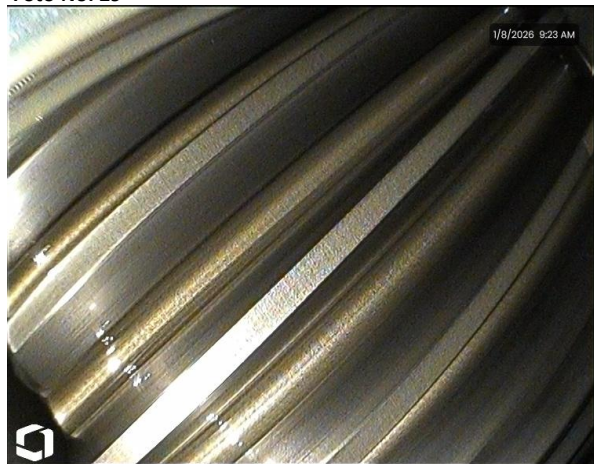
Foto No. 29

3.1.5 SU B - Sun pinion

No excessive wear or damage has been observed.

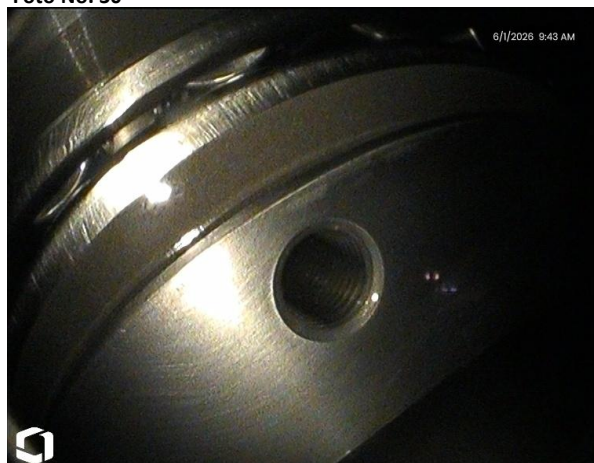
Foto No. 30

3.2.2 PC B G - Planet carrier bearing

No excessive wear or damage has been observed.

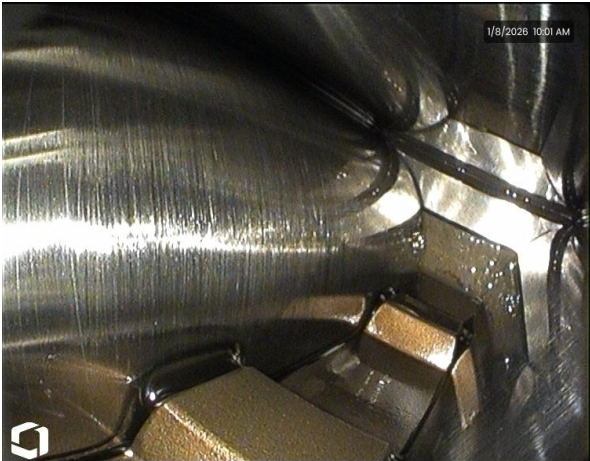
Foto No. 31

3.2.3 PB B.1 R - Planet bearing

No excessive wear or damage has been observed.

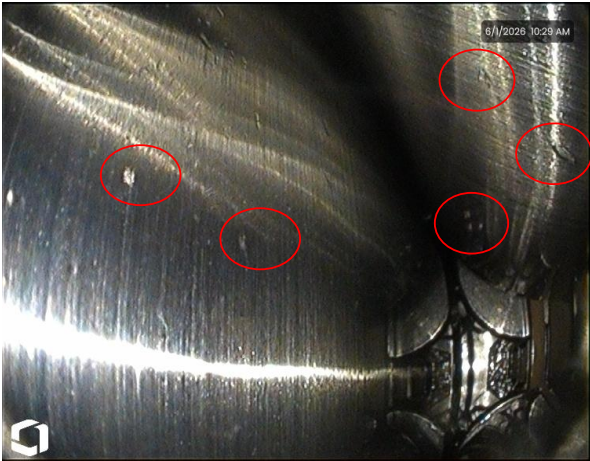
Foto No. 32

The observed wear in the form of (micro-)pitting at bearing PB B.1G (Planet Bearing B1, generator side) is considered to be progressive in nature. Progressive micropitting indicates a reduction in remaining useful life and negatively affects the reliability of the gearbox. If left unmitigated, micropitting may eventually develop into pitting and flaking.

3.2.4 PB B.1 G - Planet bearing

10 - Micropitting

Regular inspections required

(Micro-)pitting has been observed on the outer ring and rolling elements. This type of wear is detected by the accelerometer sensors.

It is recommended to perform a follow-up inspection within six months due to the observed wear inside the gearbox. In addition, the Condition Monitoring System (CMS) data should be closely monitored. If the monitored values increase, an earlier inspection than the planned six-month interval is recommended.

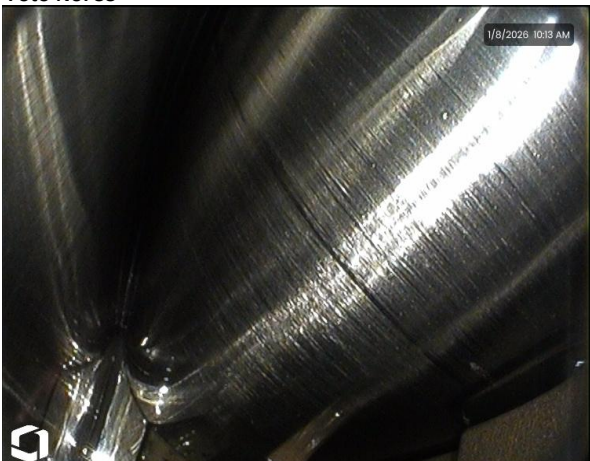
Foto No. 33

3.2.5 PB B.2 R - Planet bearing

No excessive wear or damage has been observed.

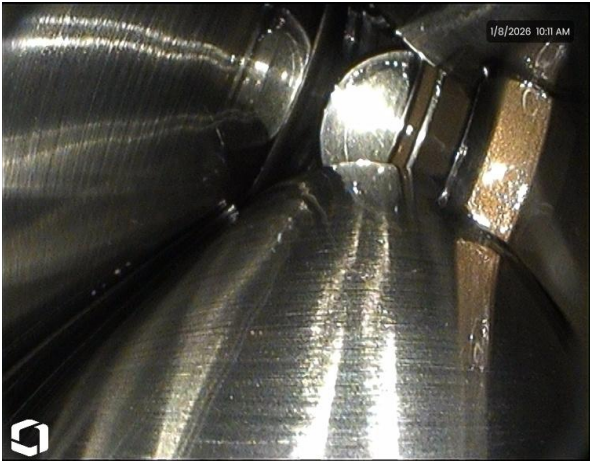
Foto No. 34

3.2.6 PB B.2 G - Planet bearing

No excessive wear or damage has been observed.

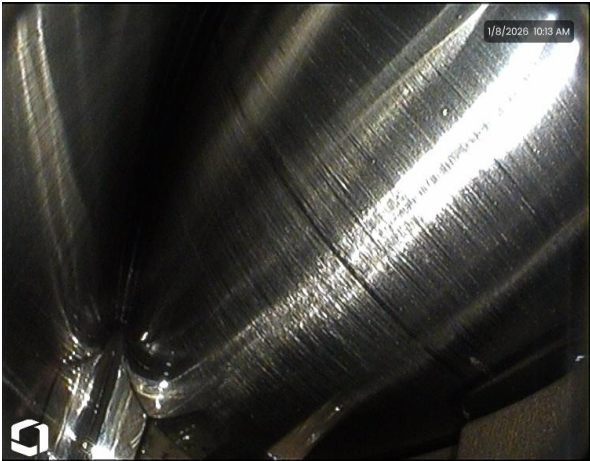
Foto No. 35

3.2.7 PB B.3 R - Planet bearing

No excessive wear or damage has been observed.

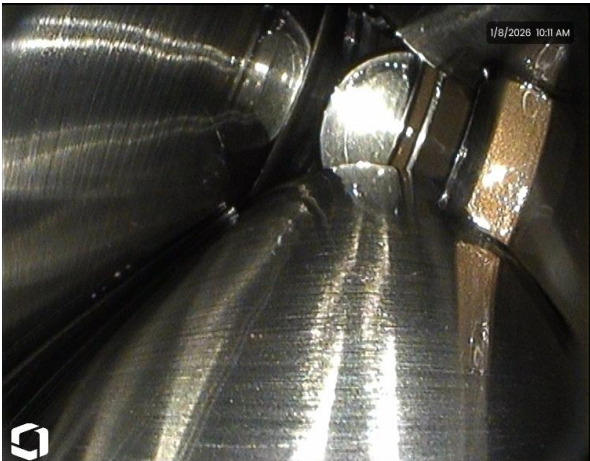
Foto No. 36

3.2.8 PB B.3 G - Planet bearing

No excessive wear or damage has been observed.

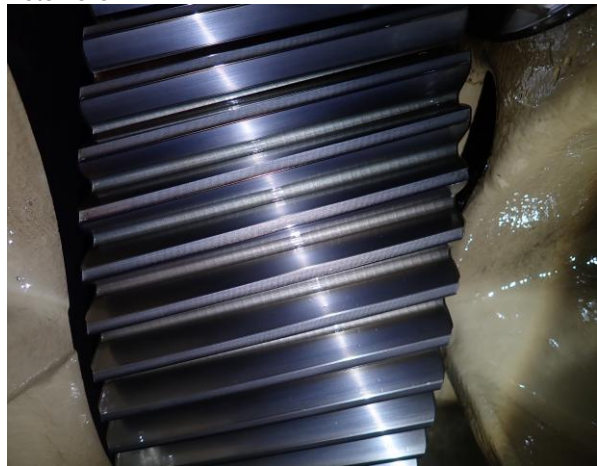
Foto No. 37

4.1.1 LSS - Low speed shaft

No excessive wear or damage has been observed.

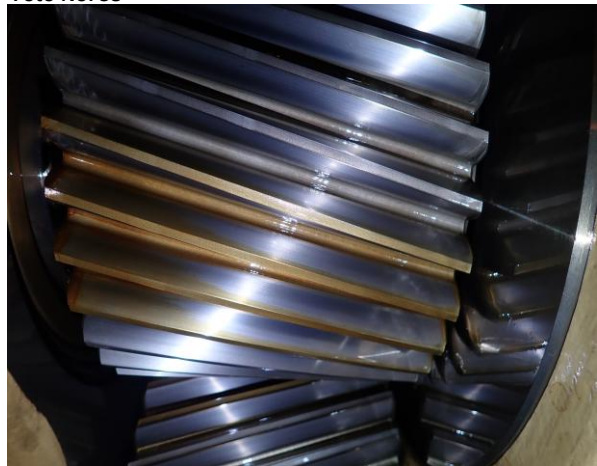
Foto No. 38

4.1.2 HSS - High speed shaft

No excessive wear or damage has been observed.

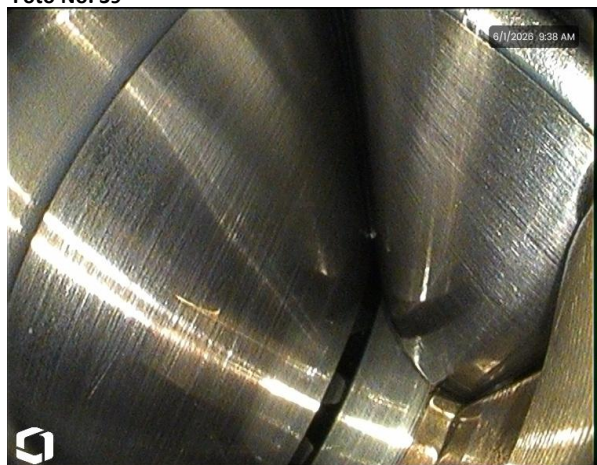
Foto No. 39

4.2.1 LSS R - Low speed shaft bearing

No excessive wear or damage has been observed.

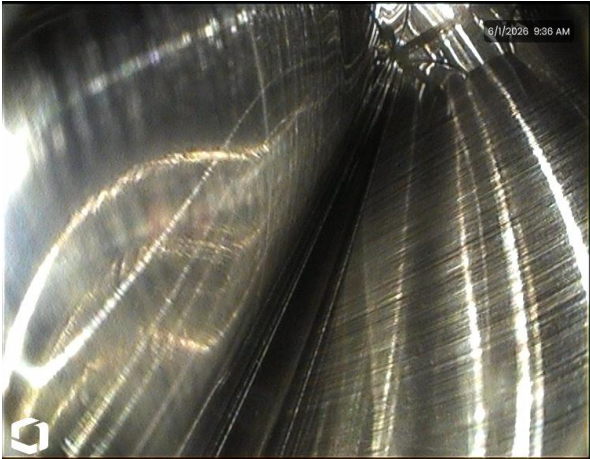
Foto No. 40

4.2.2 LSS GR - Low speed shaft bearing

No excessive wear or damage has been observed.

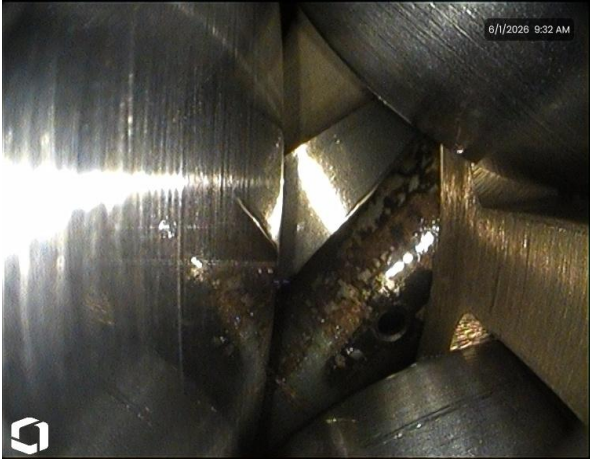
Foto No. 41

4.2.4 HSS R - High speed shaft bearing

No excessive wear or damage has been observed.

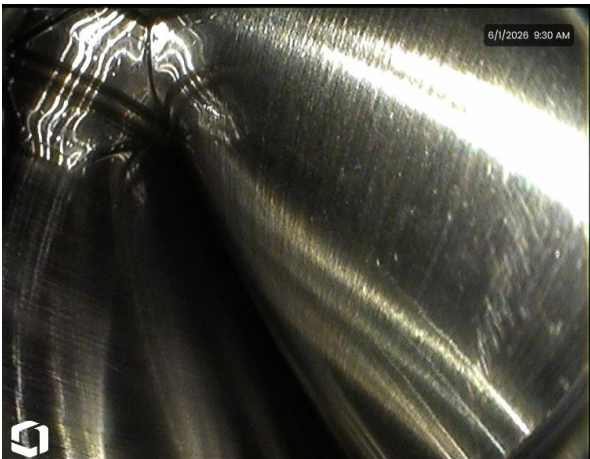
Foto No. 42

4.2.5 HSS GR - High speed shaft bearing

No excessive wear or damage has been observed.

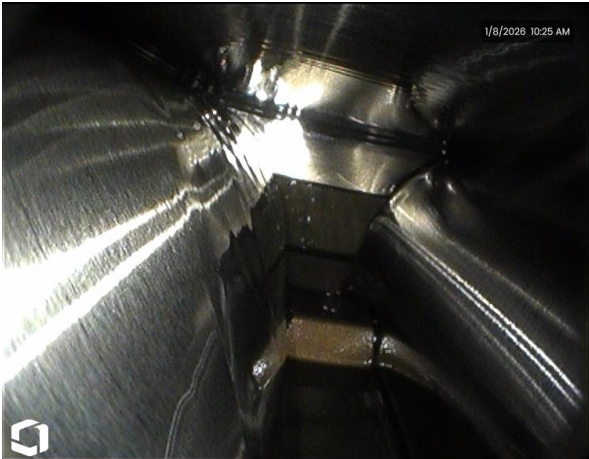
Foto No. 43

1.2.2 PC A1 G - Planet carrier bearing

No excessive wear or damage has been observed.

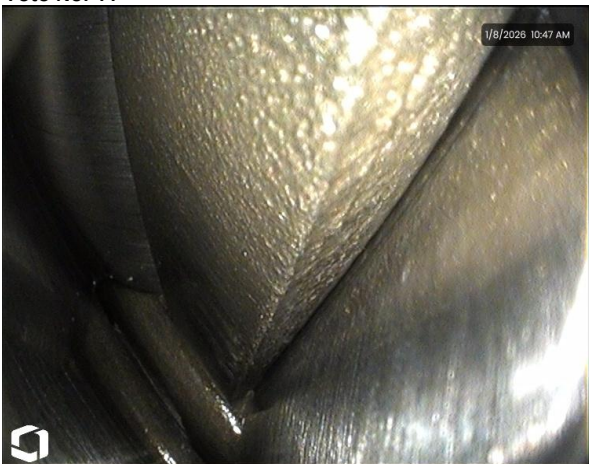
Foto No. 44

3.2.1 PC B R - Planet carrier bearing

No excessive wear or damage has been observed.
